**航空事故調査報告書**  
**ノースウェスト航空会社所属**  
**ボーイング式747-251B型N637US**  
**新東京国際空港**  
**平成6年（1994年）3月1日**

平成8年11月7日

航空事故調査委員会議決

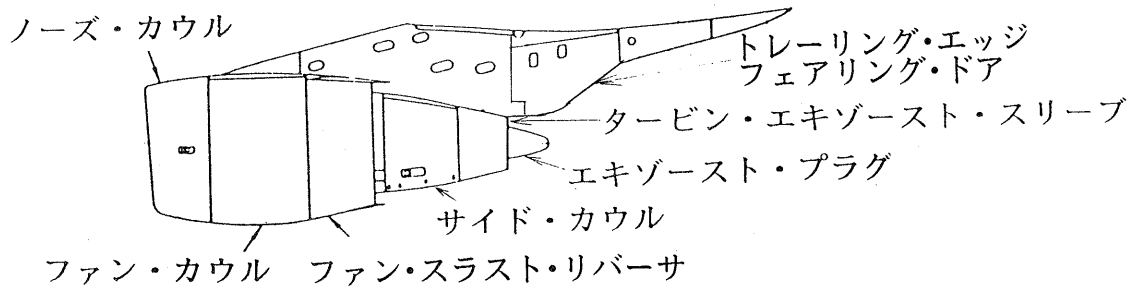
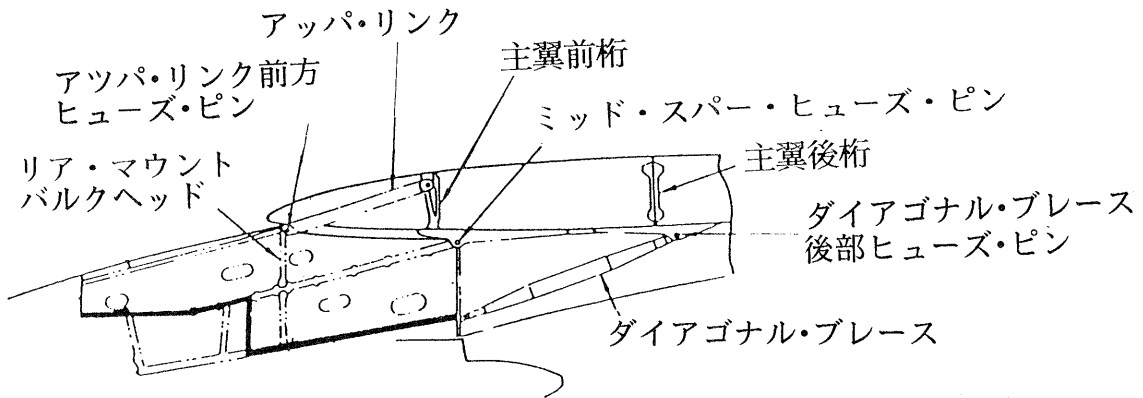
付図 6 - 1 No. 1 エンジン・ナセル・ス  
 トラット部の概要図

### 2.14.1 ナセル・ストラット (付図6 参照)

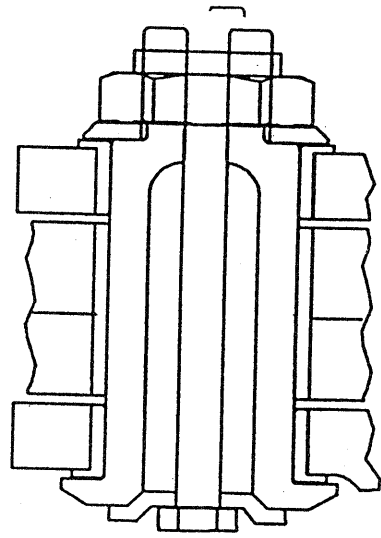
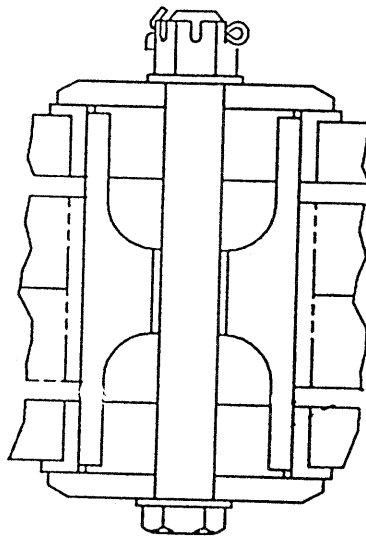
付図7 ヒューズ・ピンの形状図

同型機のヒューズ・ピンについては、当時、高張力鋼製のバルクヘッド型ヒューズ・ピンから、ステンレス鋼で、かつ、形状も変更し、強度を増加させたサード・ジェネレーション・ストレート・ボア型ヒューズ・ピンへの改修が実施中であった。（付図7 参照）

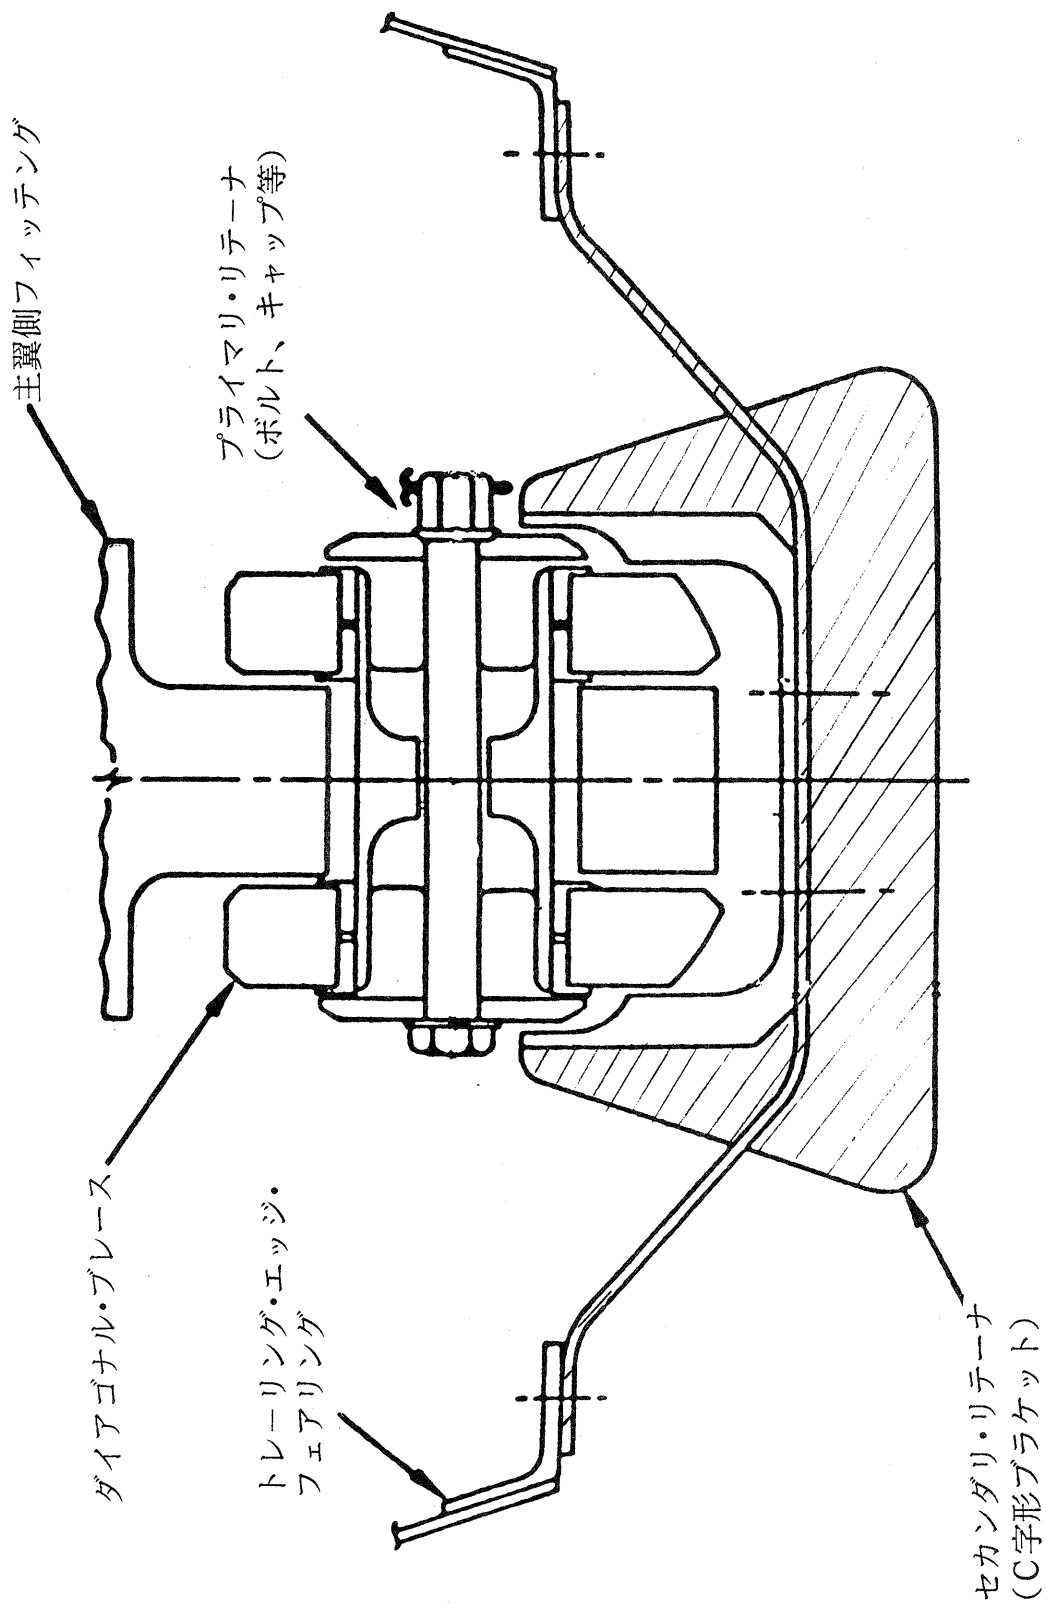
付図8 ダイアゴナル・ブレース後方ビュー  
 ーズ・ピン・セカンダリ・リテーナ概

ヒューズ・ピンには、抜け出しを防止するためのリテーナを装着するが、バルクヘッド型ヒューズ・ピンには、プライマリ・リテーナ及びセカンダリ・リテーナを装着する。プライマリ・リテーナは、2個のキャップ、1本のボルト、1個のナット及び2個のワッシャーが一組となったもので、セカンダリ・リテーナはC字形ブラケットを取付けるものである。（付図8及び写真8 参照）

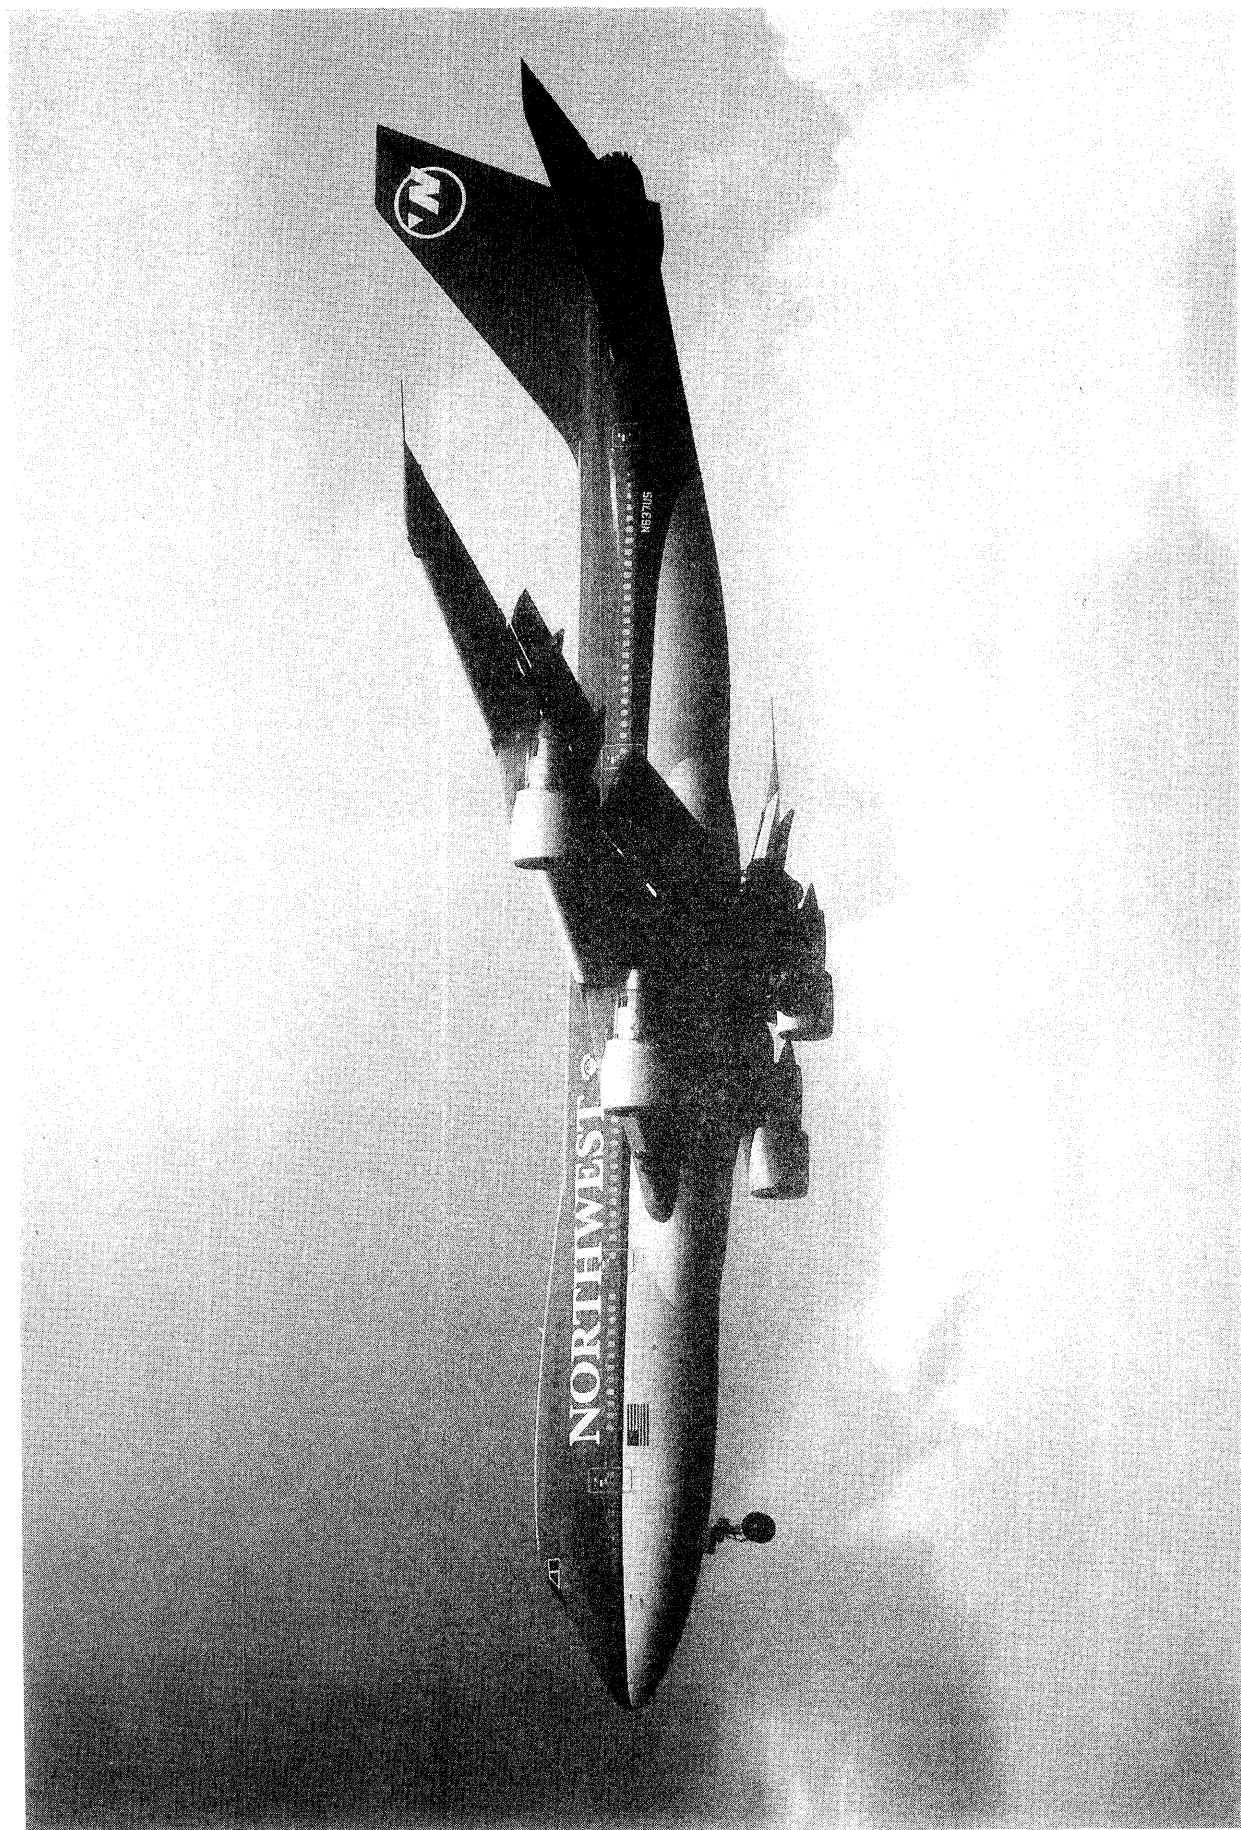
写真7 成田空港に着陸進入中の同機

着陸前の進入中の同機を目撃者した者によれば、その時点では、同機は外観上は異常は認められなかったとのことであり、その際、撮影された同機の写真からも、同機のNo. 1エンジン等に異常は認められない。(写真7 参照)

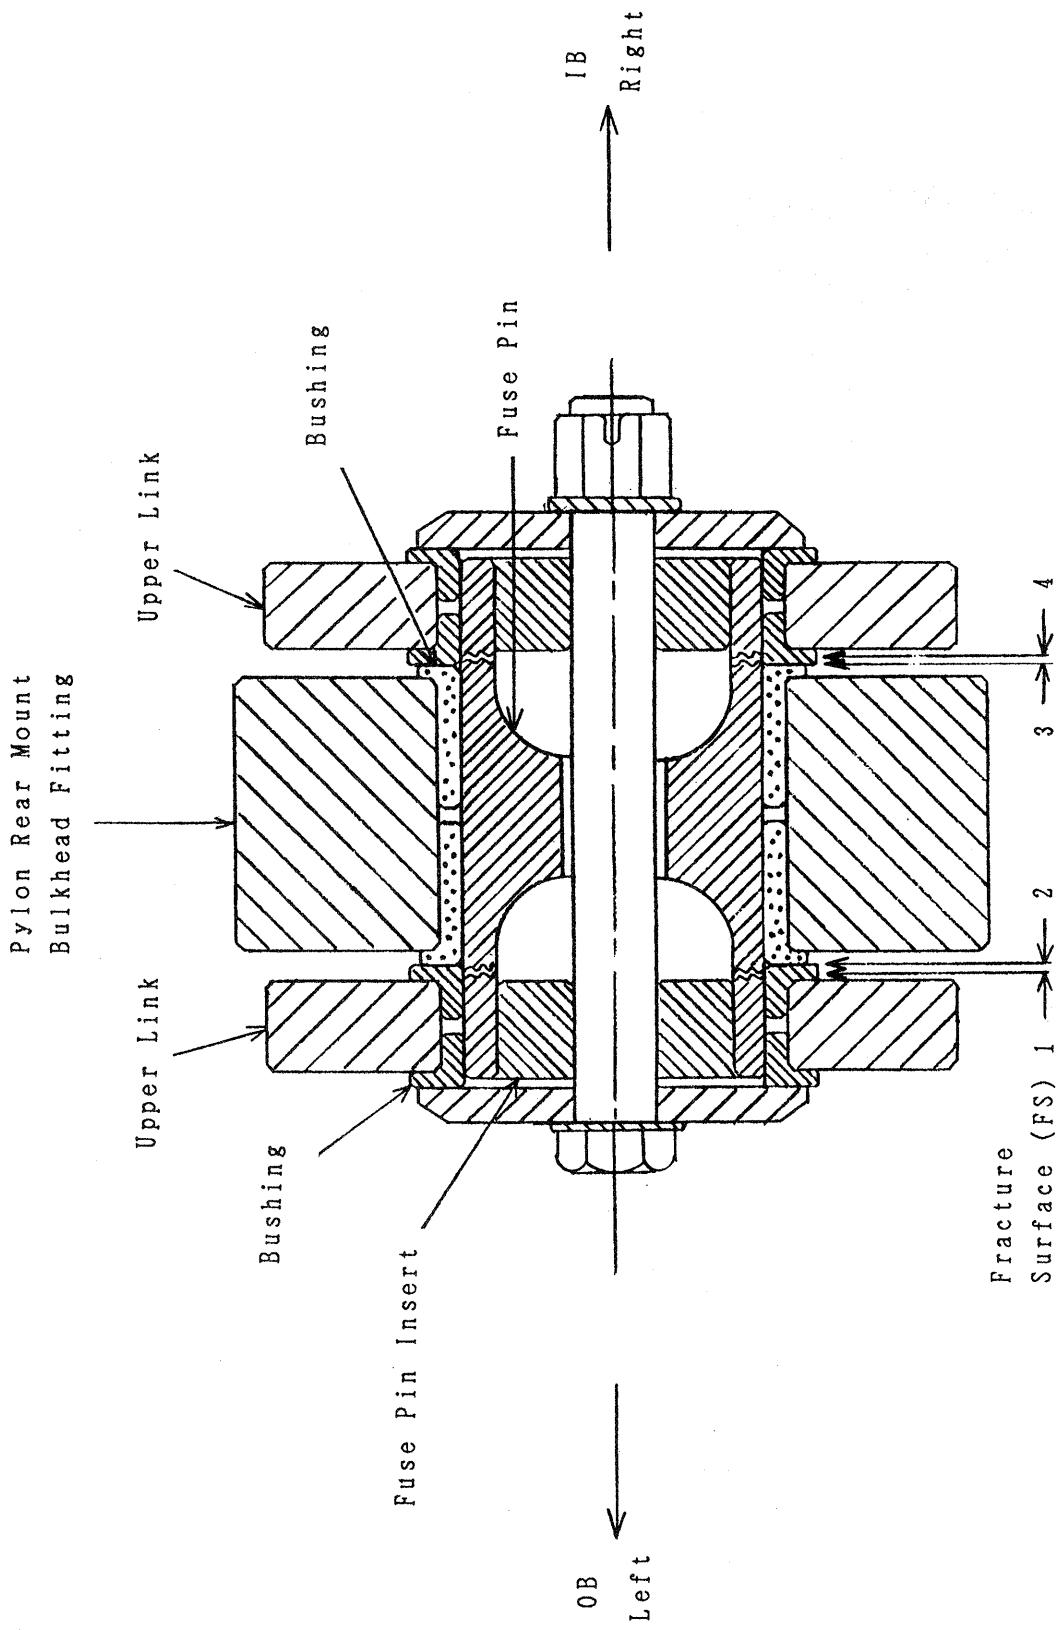
図3. Upper Link FWD Fuse Pin 取付け部の A-A断面図と破壊箇所

ヒューズ・ピンは、フィッティングとアップパ・リンクの間で破断し、3つの破片に分かれていた。

4 以上のこと及び同ヒューズ・ピンの変形測定の結果から、同ヒューズ・ピンは、アッパ・リンク軸方向に作用した過大な引張り荷重のため、まず $0^{\circ}$ 及び $180^{\circ}$ 方向の部分で剪断破壊が生じ、 $90^{\circ}$ と $270^{\circ}$ の近くでは曲げ破壊に転じつつ、最終破壊部の $270^{\circ}$ 付近では振りを伴って破断したものと考えられる。

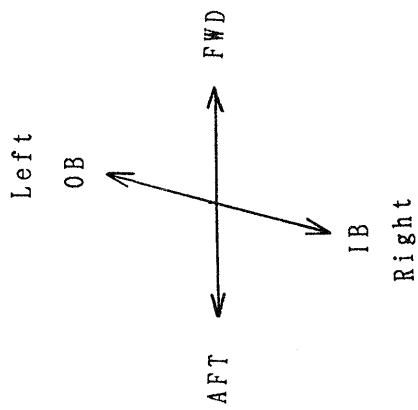
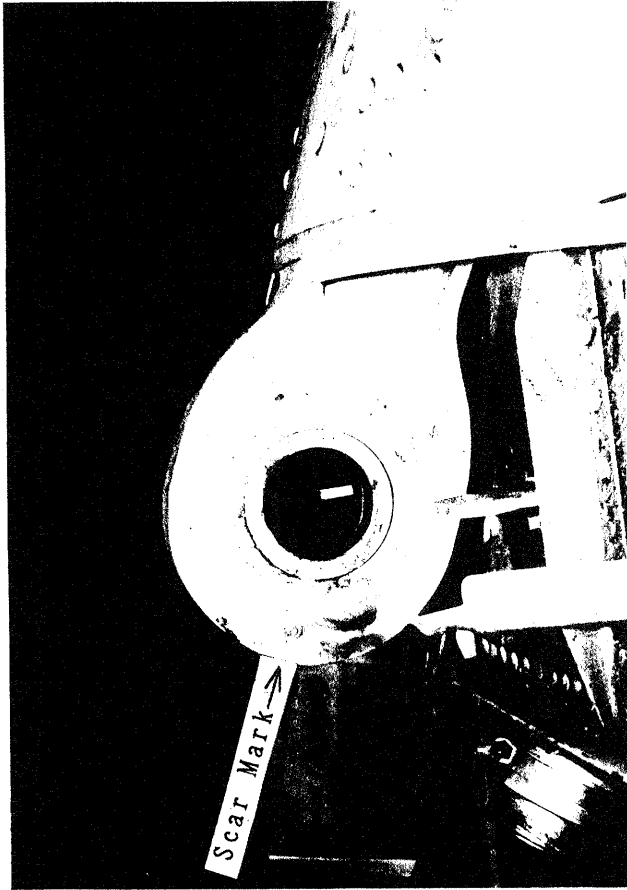
図4. Pylon Rear Mount Bulkhead Fitting  
IBあるいはRight側より写真撮影

当該穴の変形測定を行ったところ、穴はやや楕円形に変形しており、内径は $90^{\circ}$  -  $270^{\circ}$ 方向に比べ、 $0^{\circ}$  -  $180^{\circ}$ 方向では約 $0.4\sim 0.8\text{mm}$ 大きくなっていた。

この変形が過大な荷重の作用によるものと仮定すると、ボーイング社の材料仕様の降伏応力とフィッティング形状寸法から、作用した荷重は約 $1,003\text{kN}$ と推算できる。この力は同ピンに作用する剪断応力に直すと $857\text{MPa}$ と推算でき、これは、破断したヒューズ・ピンについて測定したビッカース硬さより求められる引張り強さ $1,365\text{MPa}$ からミーゼスの式（剪断応力=引張応力/ $\sqrt{3}$ ）で推算される剪断強さ $788\text{MPa}$ を上回り、かつ、ボーイング社の材料仕様の引張強さの値からミーゼスの式で推算されるヒューズ・ピンの剪断強さを超えるものである。

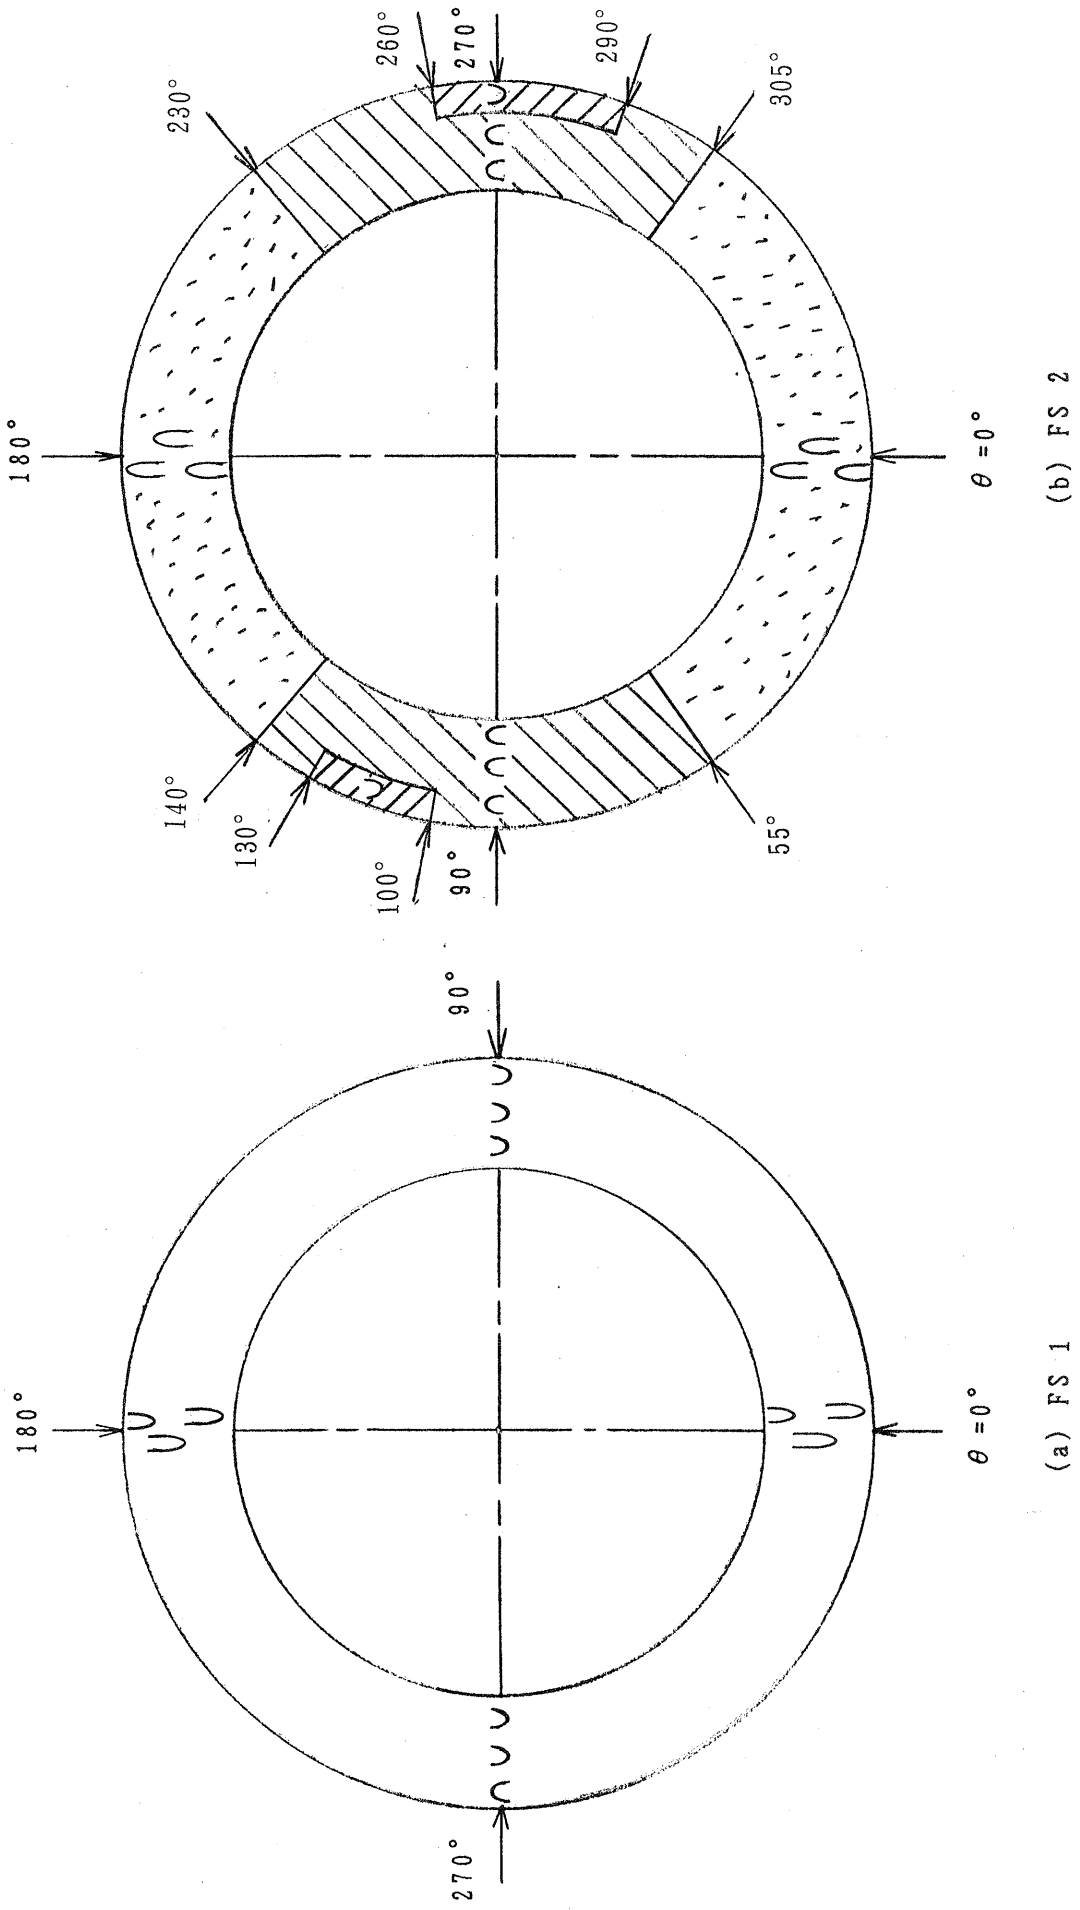
図10. Upper Link FWD Fuse Pin 破面における  
ディンプル方向(その1、FS1と2)

各破面は、何れも0°と180°を中心とするほぼ±60°の範囲では、剪断破壊の特徴である伸長ディンプルが多く認められた。

各破面の90°と270°を中心とする約±30°の範囲では、ディンプルの長さは短くなり、引張り破壊の特徴である等軸ディンプルも部分的に認められた。

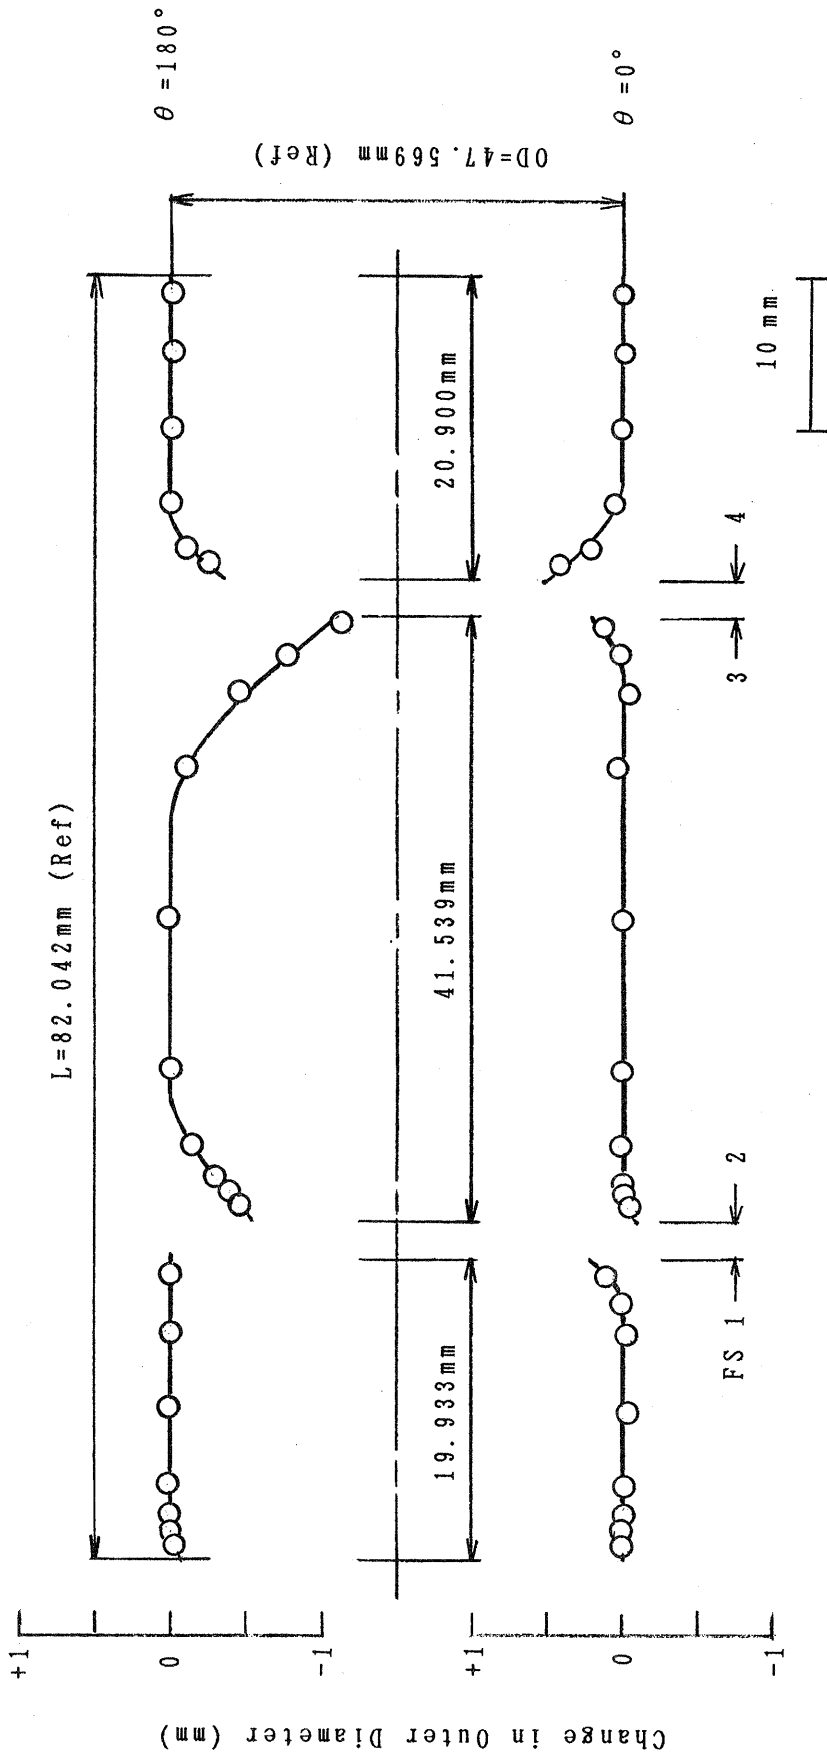
図14. Upper Link FWD Fuse Pin 外径変化の軸方向分布  
(その1、基準参照マークから  $\theta = 0^\circ$  と  $180^\circ$  の位置)

(1) Fuse Pinの外径変化は破面1、4側で小さく、破面2、3側で大きくなった。これは破面1、4側では外側はUpper Link、内側はInsertによって拘束されていたが、破面2、3側では内側が空洞であったことによると考えられる。

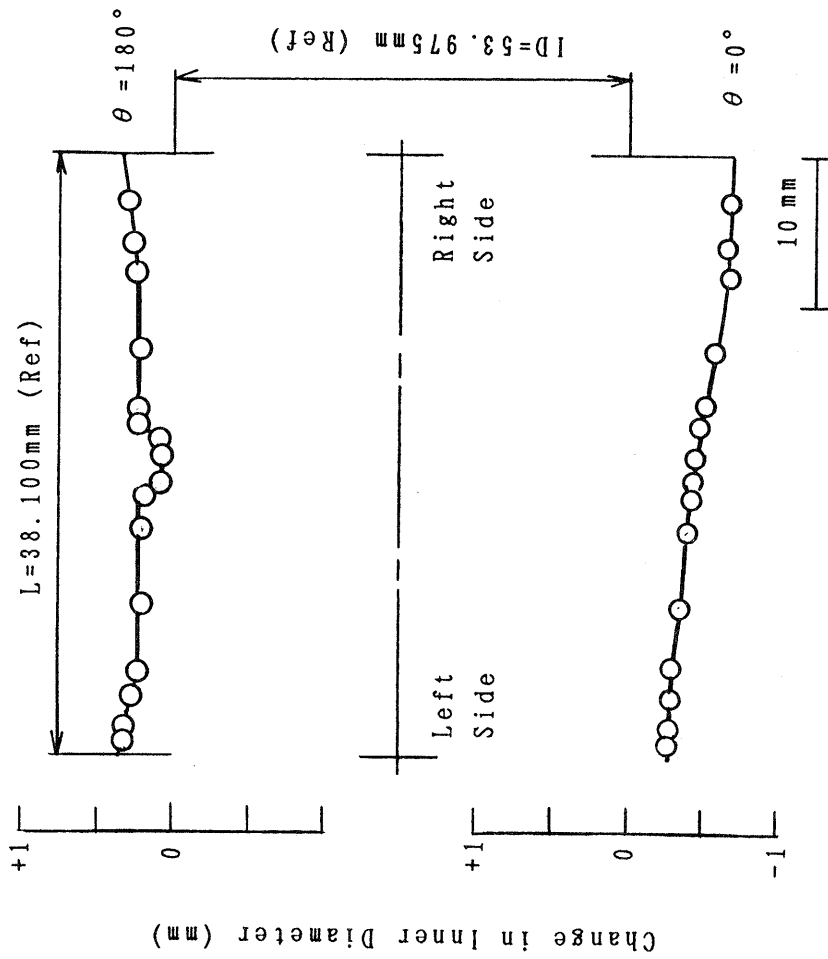
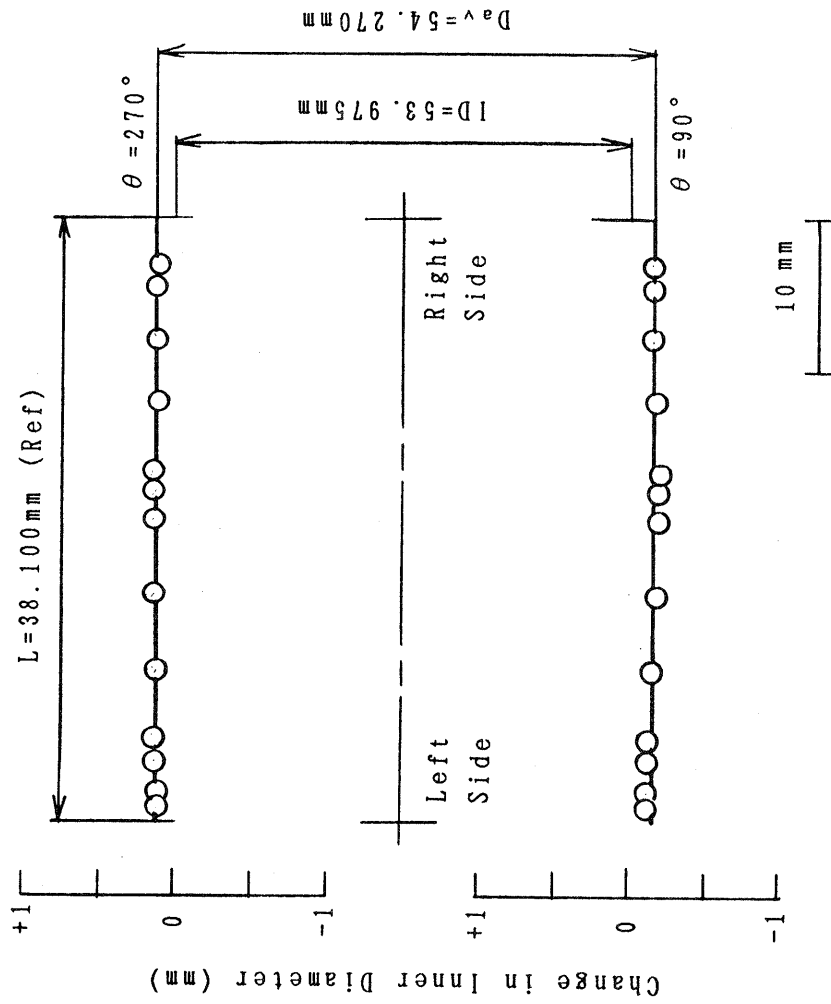
図16. Pylon Rear Mount Bulkhead Fitting内径変化の軸方向分布

前提として、図14においてPylon Rear Mount Bulkhead Fittingが0° - 180° 方向すなわち外力作用方向を長軸とする楕円形に變形していたことより、この図の下側の図(a)においてハッチングで示す部分が降伏していたと考えた。この前提に従うと、Fittingを變形させた力Fが式(1)で推定できる。

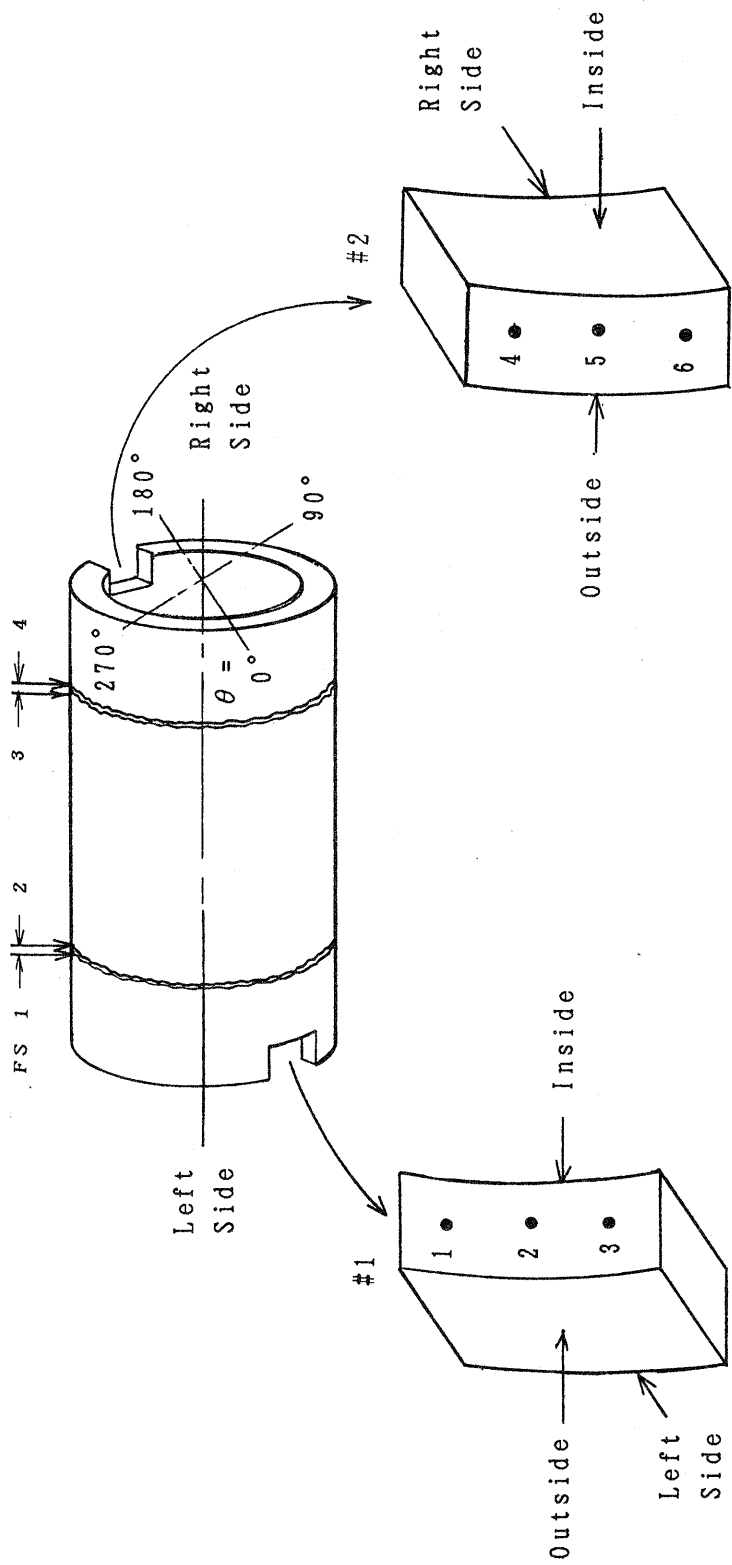
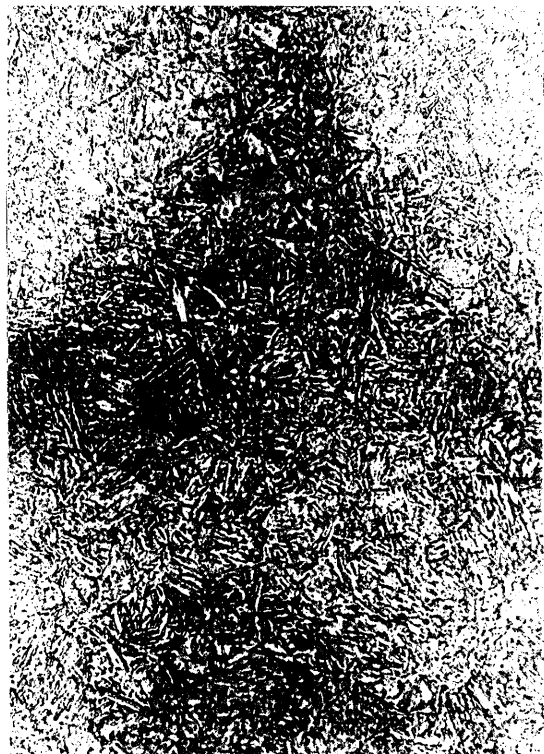
- 2 破断したピンの両端部から各1つの試料を切り出し、ピン横断面について金属組織調査及びビッカース硬さ試験(HV20)を行った。

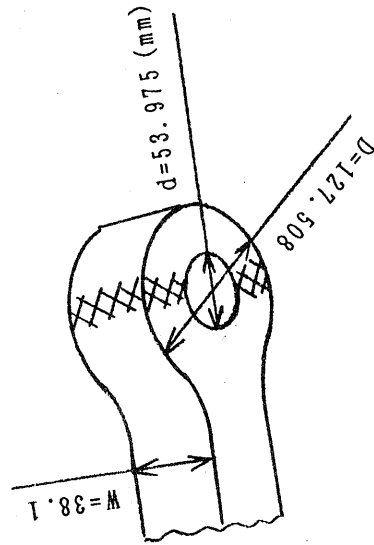
図(a) Pylon Rear Mount Bulkhead Fittingの設計寸法

$$F \geq A_1 \times \sigma_y = 1003 \text{ kN} \quad \dots\dots\dots (1)$$

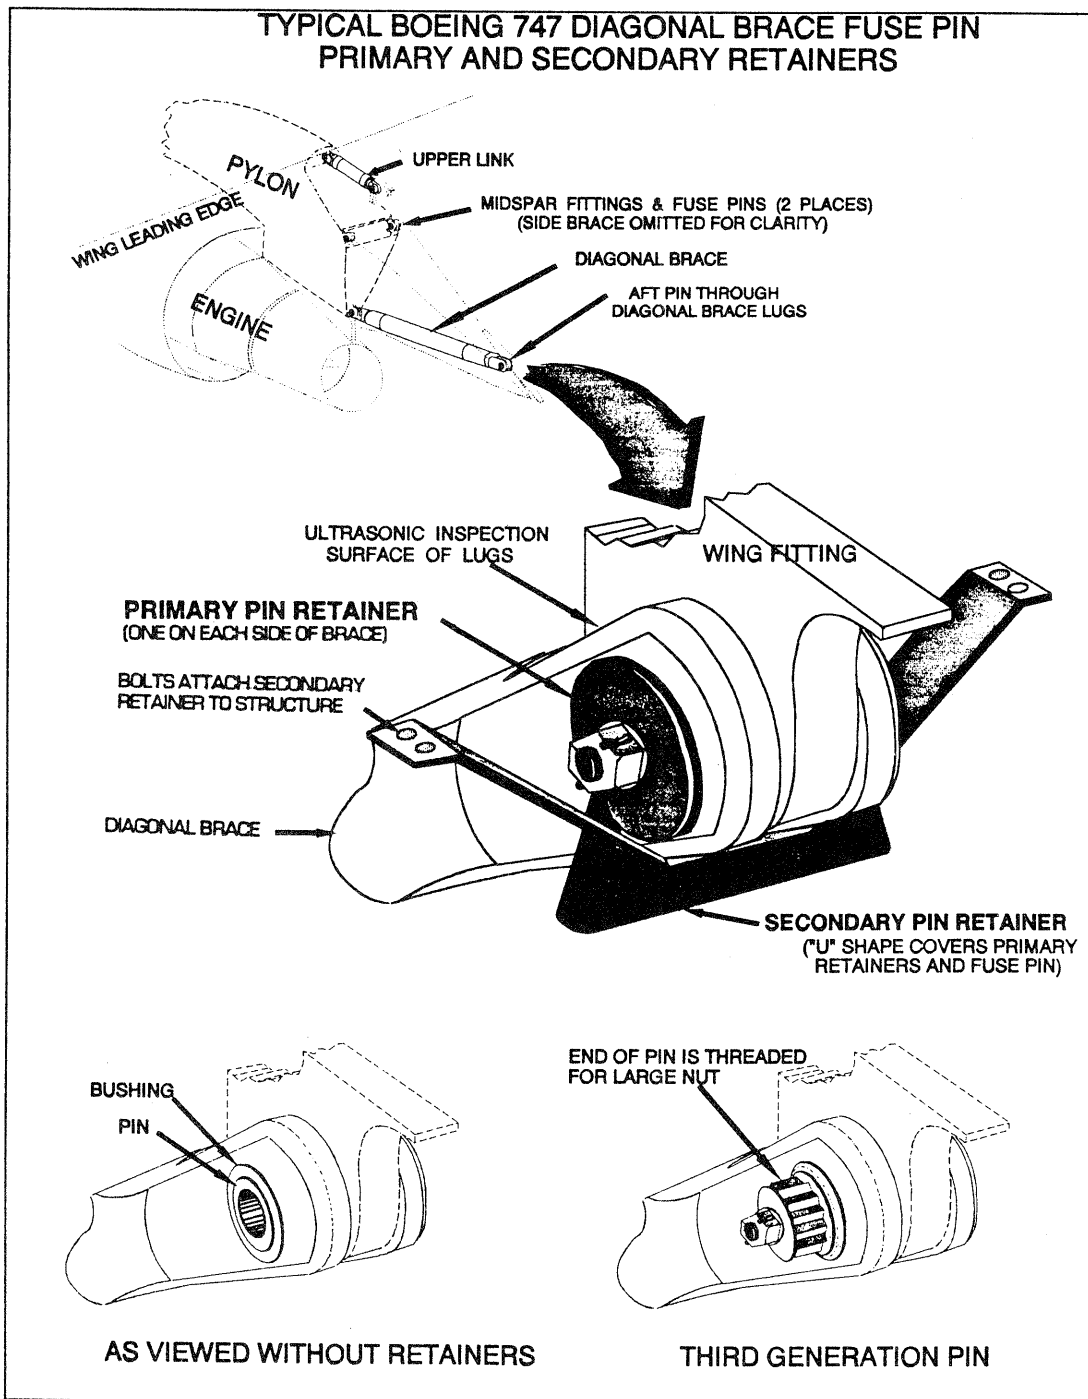
Figure 2.--Diagonal brace attachment details.

Prior to this landing, at some unknown time, the aft fuse pin on the pylon diagonal brace had migrated out of its fitting. The pin was found loose in the pylon structure. It was intact, undamaged, and had no evidence of preexisting defects. The aft diagonal brace fuse pin is normally retained by both a primary retainer (two washer-like retainer caps and a through bolt) and a secondary retention clip (a bolt-on C-shaped bracket). (See figure 2). However, a search of the airplane pylon and engine area, as well as the runway surface at Narita, revealed neither the aft diagonal brace fuse pin primary nor secondary retaining devices.

The day after the accident, NWA personnel advised the Safety Board and the JAAIC that a set of diagonal brace fuse pin primary and secondary retainers had been found in the NWA maintenance facility in an unmarked white cloth bag. According to NWA officials, the bag was found between the hand rail and a piece of "2 by 4" wooden board on the left under-wing work stand. This was adjacent to where work had been performed on the No. 1 engine of N637US. Prior to the accident, N637US had undergone a "C" check at that work stand in NWA's maintenance facility. The "C" check had included maintenance and inspection of the diagonal brace fuse pin lugs.

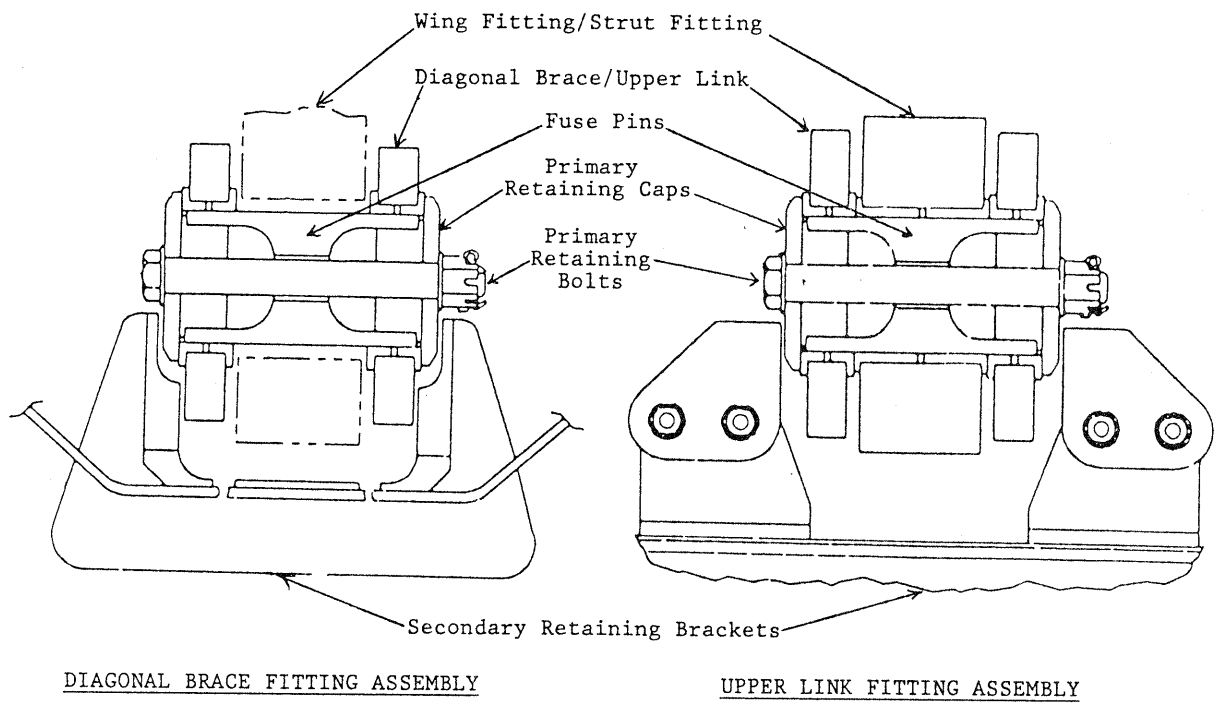
Figure 3.--Diagonal brace and upper link fitting assemblies.

The fractured forward upper link fuse pin from the No. 1 pylon was recovered in three pieces and was retained by the JAAIC for metallurgical examination. Examination of the pin revealed that it fractured in static overload and that there was no evidence of preexisting fatigue.

The March 1, 1994, NWA Fleet Information Register indicates that the airline operates 41 B-747 airplanes of various models. NWA officials stated that 7 airplanes, numbers 6631, 6632, 6636, 6637 (the accident airplane), 6638, 6739 and 6740, of its 31 B-747 aircraft, have the secondary retainers installed on the aft diagonal braces, unless the third generation of pins had been installed. Third generation pins required no secondary retaining devices. (See figures 2 and 3).<sup>1</sup>
