**FINAL ACCIDENT INVESTIGATION REPORT**

**AIRBUS A321-211**

**G-VOLH**

**18<sup>TH</sup> APRIL 2001**

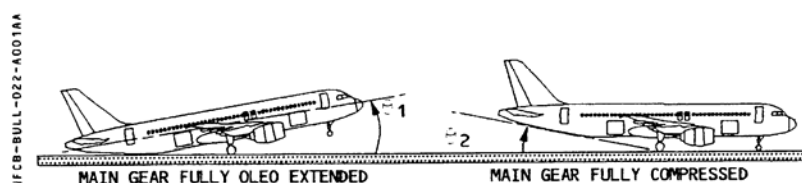
From the geometry of the impact damage, the aircraft pitch attitude would have been between 10° and 11° relative to the runway.

Two limits are critical :

- the geometry limit corresponding to main gear oleo fully extended ( $\Theta_1$ )
- the geometry limit corresponding to main oleo gear fully compressed ( $\Theta_2$ ).

A319	A320	A321
$\Theta_1$	15.7°	13.7°	11.4°
$\Theta_2$	13.9°	11.7°	9.7°

*Note : On A321, the installation of a TFS antenna decreases these values.*
