FINAL ACCIDENT INVESTIGATION REPORT

AIRBUS A346-600

EC-IZX

REPORT Nr. 37/ACCID/2004

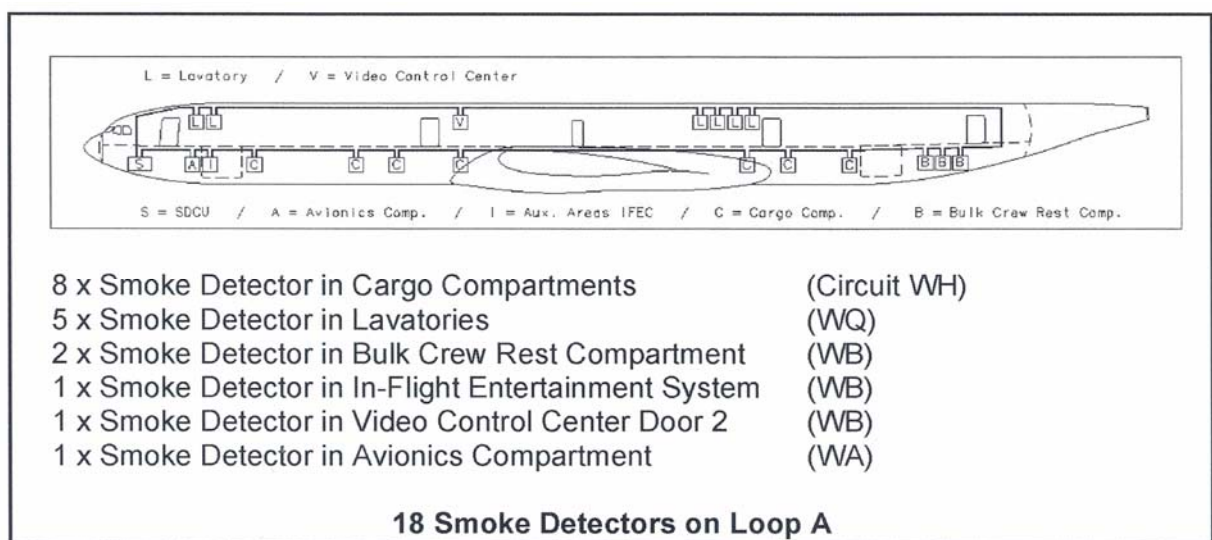
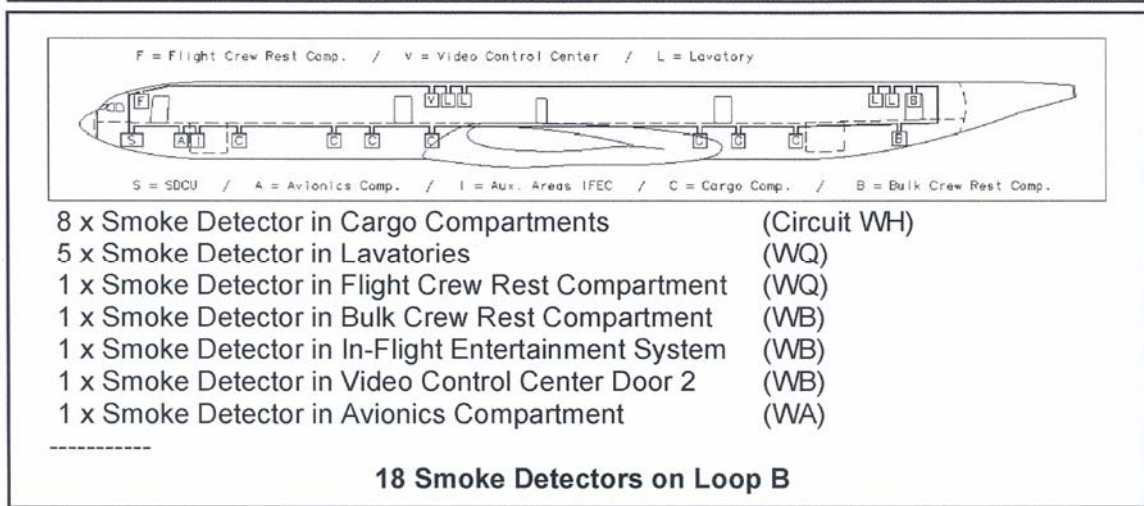
They are distributed over the cabin and segregated in 2 loops A and B as follows:

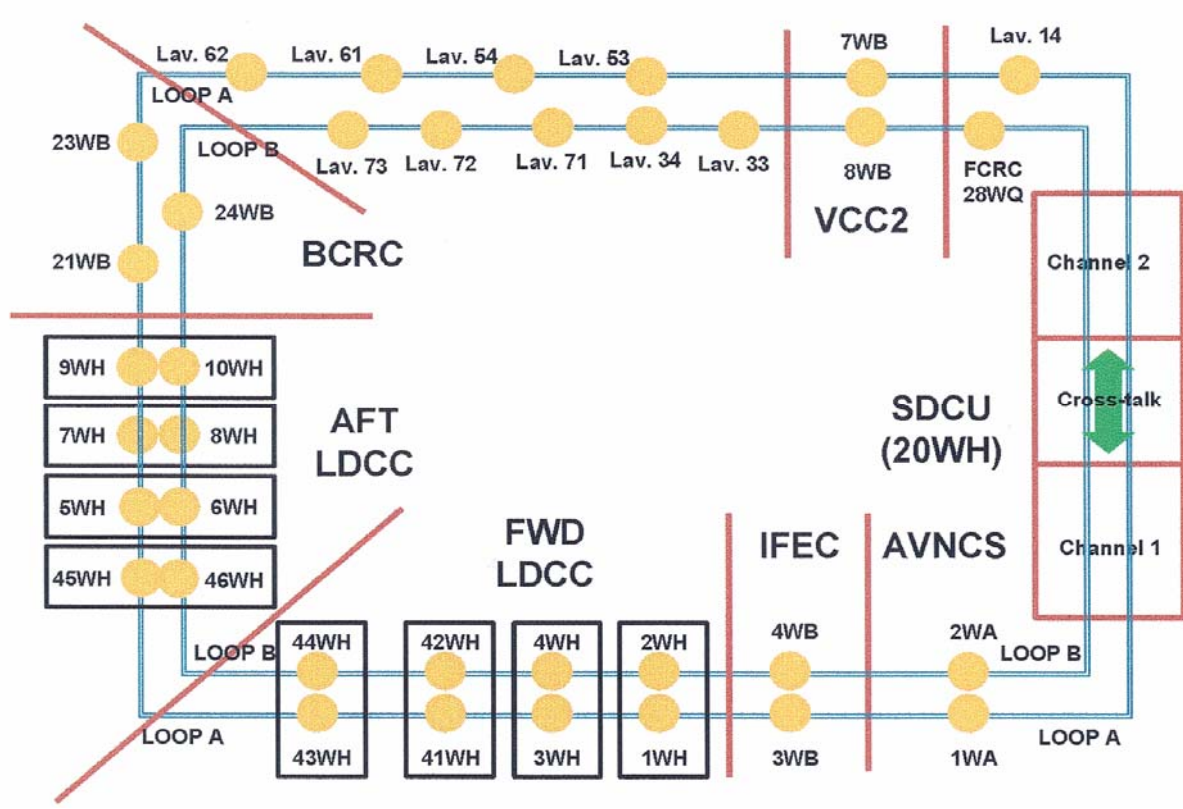
All the smoke detectors are connected in series in the order illustrated in the following sketch:

- Loop A: Channel 1, 1WA, 3WB, 1WH, 3WH, 41WH, 43WH, 45WH, 5WH, 7WH, 9WH, 21WB, 23WB, Lav62, Lav6l, Lav54, Lav53, 7WB, Lavl4, Channel 2;
- Loop B: Channel 1, 2WA, 4WB, 2WH, 4WH, 42WH, 44WH, 46WH, 6WH, 8WH, 10WH, 24WB, Lav73, Lav72, Lav7l, Lav34, Lav33, 8WB, 28WQ, Channel 2.

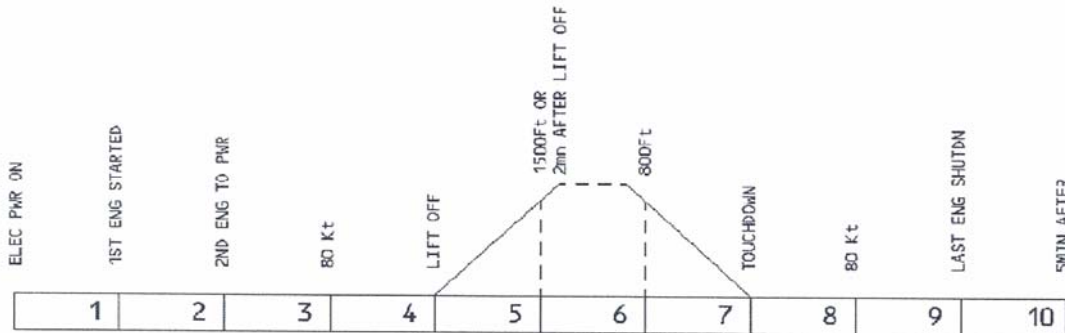
FDR indicated that the master caution triggered when aircraft speed was 80kt. This corresponds to the FWC computing the switching from phase 8 to phase 9. Indeed, flight phases are defined as follows:
