FINAL INCIDENT INVESTIGATION REPORT

MONARCH AIRWAYS

AIRBUS A321-231

G-OZBE

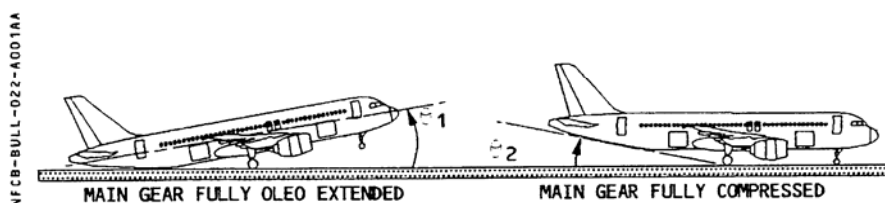
Two limits are critical :

- the geometry limit corresponding to main gear oleo fully extended (Θ_1)
- the geometry limit corresponding to main oleo gear fully compressed (Θ_2).

From the geometry of the impact damage, the aircraft pitch attitude would have been between 10° and 11° relative to the runway.
