FINAL INCIDENT REPORT

Cessna 208B

N21070

24th of December 2008

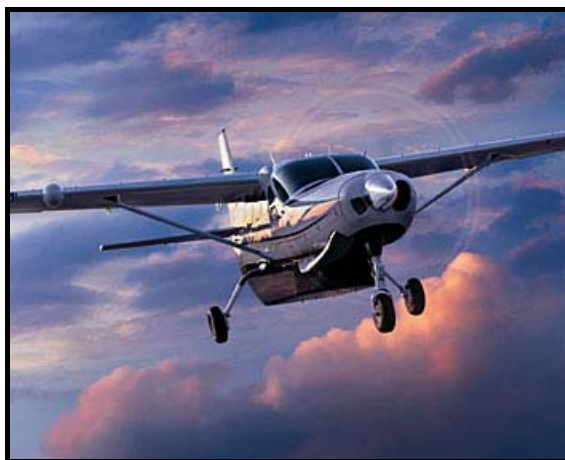
Picture Nr: 2

The 208B Grand Caravan first flew in 1990 and is a stretched version of the basic Caravan powered by a 505kW (675shp) PT6A-114, mounted with a McCauley three bladed, constant speed, full feathering, reversible, 106inch diameter propeller. It has a maximum take-off mass (MTOM) of 8750lbs (3969kgs) and can seat up to 14 passengers for a range of 917NM (1698km) at a maximum altitude of 25000ft (7620m) and a maximum cruising speed of 184kts (341km/h).
