FINAL INCIDENT REPORT

PRIVATE
EXTRA 300S

N80LA

FINAL INCIDENT REPORT Nr. 18/INCID/2008

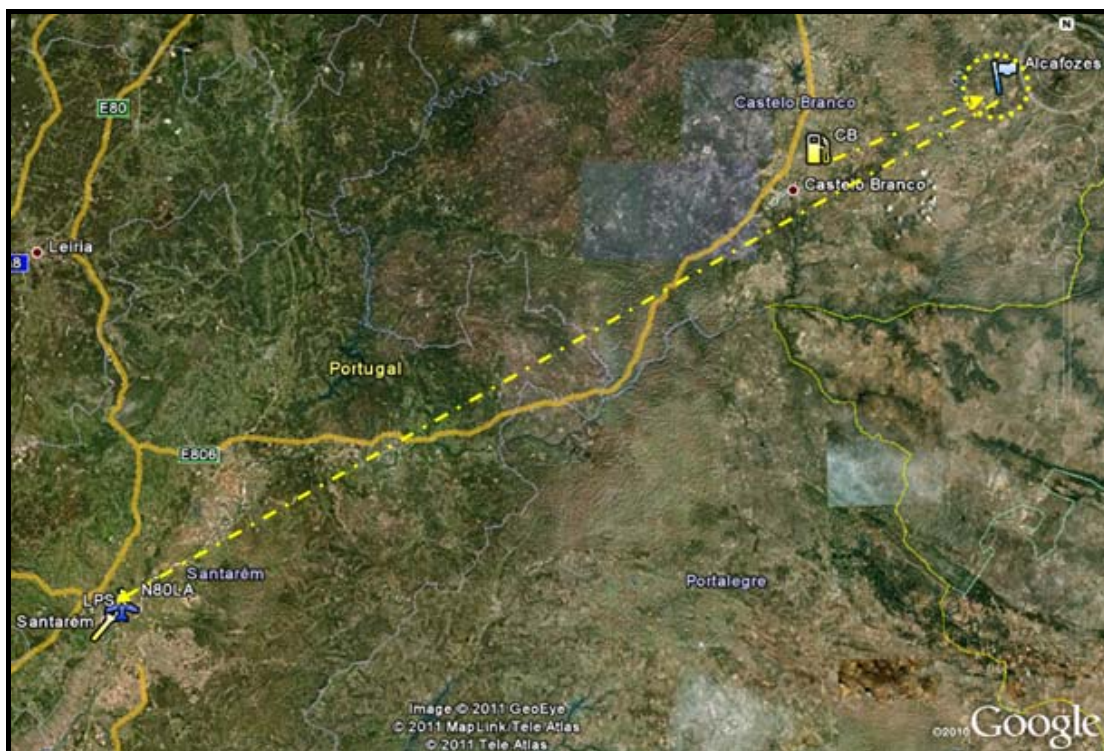
Picture Nr 1

The aircraft took-off at 11:40 for a trip of ten minutes time to Alcafozes, where it had to hold for another five minutes, prior to its display of eight minutes, after which it headed to Santarém (*picture nr 1*).

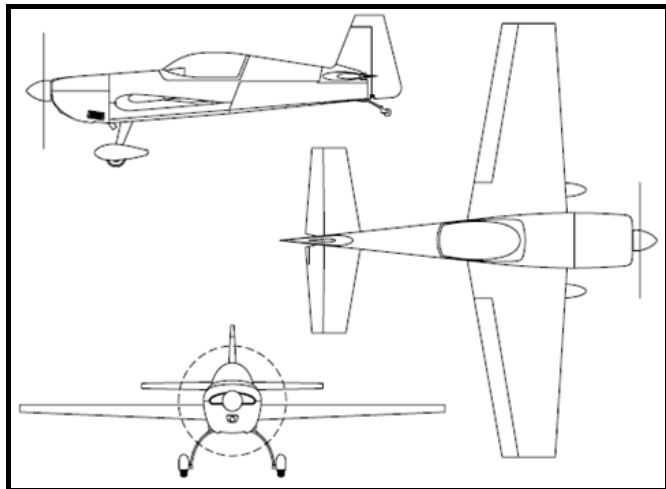
Picture Nr 4

The aircraft EXTRA 300/S (*picture nr 4*) was designed and developed by Extra Flugzeugproduktions, in Federal Republic of Germany and registered in normal and acrobatic categories. It's a light weight, robust, single piston-engined, one seat aircraft with a fuselage structure in TIG welded steel tube construction and landing gear, wing and tail made of epoxy, reinforced with glass and carbon fibre.

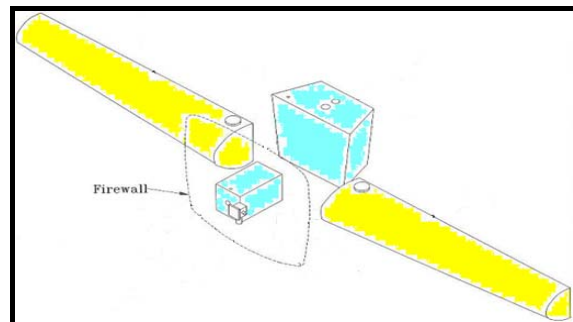
Picture Nr 5

The EXTRA 300S aircraft is equipped with two independent fuel systems (*picture nr 5*):

- a) Acro & Centre tank system (*mounted in the fuselage*);
- b) Wing tanks system (*mounted in the root section of each wing, in front of main spars*).

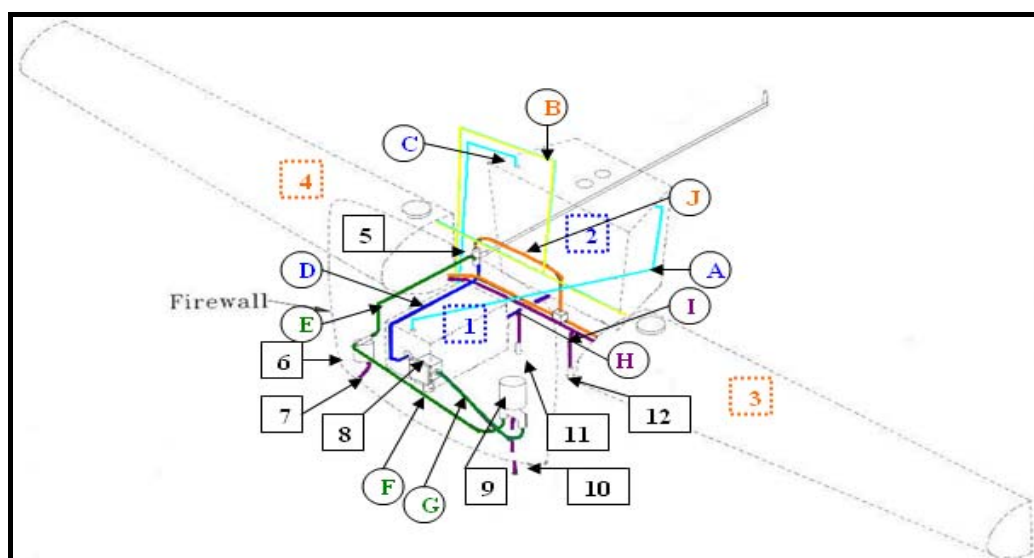
Picture Nr 6

The 2.3US Gal. capacity Acro tank (1, *picture nr 6*), incorporating an inverted flight fuel supply system, is mounted in the fuselage, just behind the firewall. It is connected to the 11.1US Gal. capacity Centre tank (2), which is mounted behind the main spar area, by a flexible hose (H). Fuelling Acro & Centre tanks is by means of a fuselage filler cap, on top. Acro tank de-aerates into the Centre tank (A), which de-aerates, by a ventilating tube (C) ending outside the fuselage at the right side of main landing gear spring. Draining of Acro & Centre tanks is accomplished by a common drain valve (11) situated under the fuselage, on right hand side, behind main landing gear.

The root section of each wing, in front of main spars, forms an integral fuel tank of approximately 59" (150cm) length (3 & 4, picture nr 6). Each Wing tank, with a capacity of 15.85US Gal., has a filler cap for gravity fuelling and they are interconnected by fuel and ventilation lines. The main ventilation tube (B) ends outside the fuselage, at right side of main landing gear spring. Draining of Wing tanks is accomplished by one common drain valve (12) situated under the fuselage, on left hand side, behind main landing gear.

When the aircraft was lifted, to be removed from the site, centre tank fuel drain was found detached from main line. No other damage was found, regarding fuel system components. All tanks and fuel lines were clean and there were no leaks.

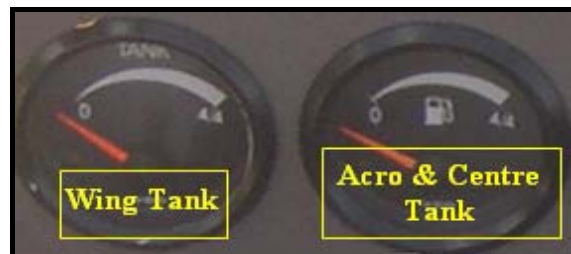
Picture Nr 7

Fuel quantity indication is provided in the cockpit by two indicators (picture nr 7), one connected to a tubular tank unit located in centre tank and another connected to a liver-type tank unit located in left wing tank. Maximum fuel quantity as follows (table nr 3):
