## **FINAL ACCIDENT REPORT**

**EXTRA 300L**

**D-EMCK**

**FINAL ACCIDENT REPORT Nr. 12/ACCID/2008**

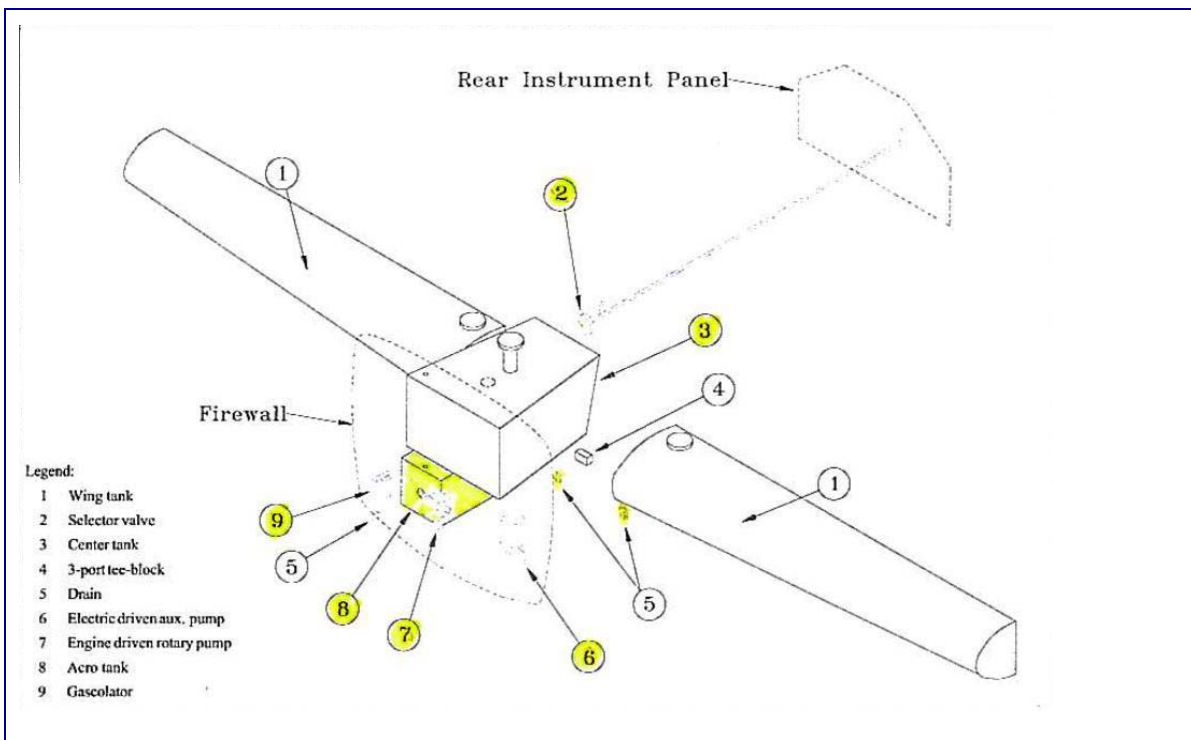
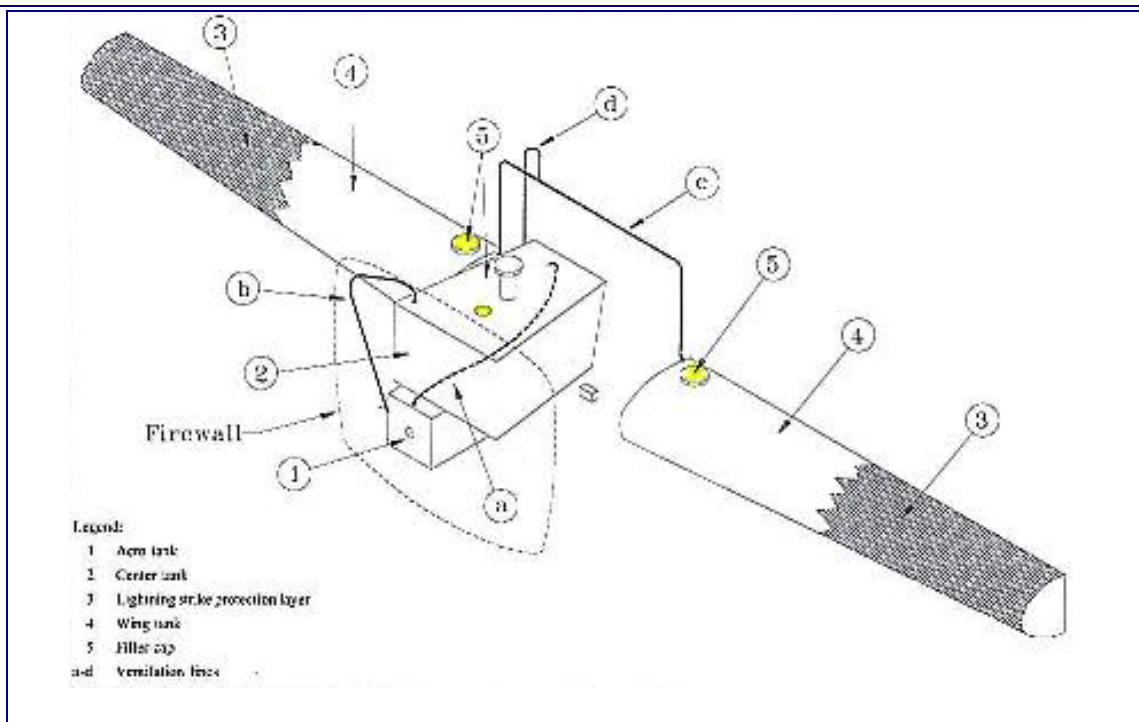
- Two tanks in the wings with 120lts (60+60) capacity and
- Central /acrobatic tank (interconnected) with 51lts capacity (42 on central plus 9 on acrobatic tank) being 5.5 no usable fuel.

A fuel selector valve, one fuel indicator for central tank and another one for wing tanks, independent drain and vent systems, one filter, an engine driven fuel pump and an electrical auxiliary fuel pump, able to feed the engine at maximum power and replace mechanical pump in case of failure, were other fuel system parts.
