MINISTÉRIO DAS OBRAS PÚBLICAS, TRANSPORTES E COMUNICAÇÕES
GABINETE DE PREVENÇÃO E INVESTIGAÇÃO DE ACIDENTES COM AERONAVES
GPIAA

FINAL INCIDENT REPORT

EMA
(EMPRESA DE MEIOS AÉREOS)
KAMOV KA-32A 11BC

CS-HMN

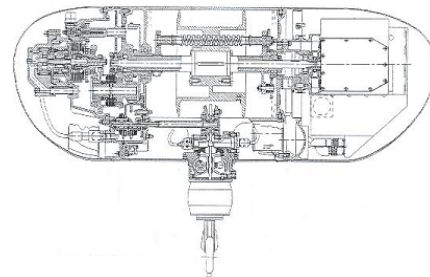
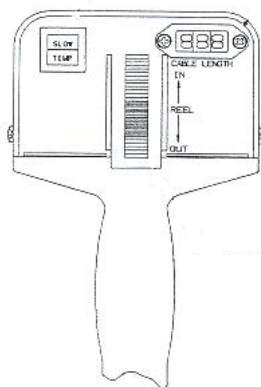
Hoist Assembly:

- P/N: 00462ASSY44311-10-2
- S/N: 00028
- CPN: 78286 SOC N: 92850/02805
- S/N: B 447

At first sight, one could notice sooting marks and missing paint on hoist assembly cover (*picture nr. 2*) caused by a heat source. Once the cover was removed, colour changes were noticed on some electronic components, revealing the equipment has been submitted to extreme temperatures. Hoist was reassembled and sent to the factory for deeper investigation.

When received at factory, hoist 00028 was installed on the Test Stand and force applied. It was observed that hoist brake system would not support a load greater than 300lb, instead of the rated 600lbs, which confirmed the reported failure.
