## **FINAL ACCIDENT REPORT**

**Airbus A320  
SATA INTERNACIONAL**

**CS-TKO**

**REPORT Nr 33/ACCID/2009**

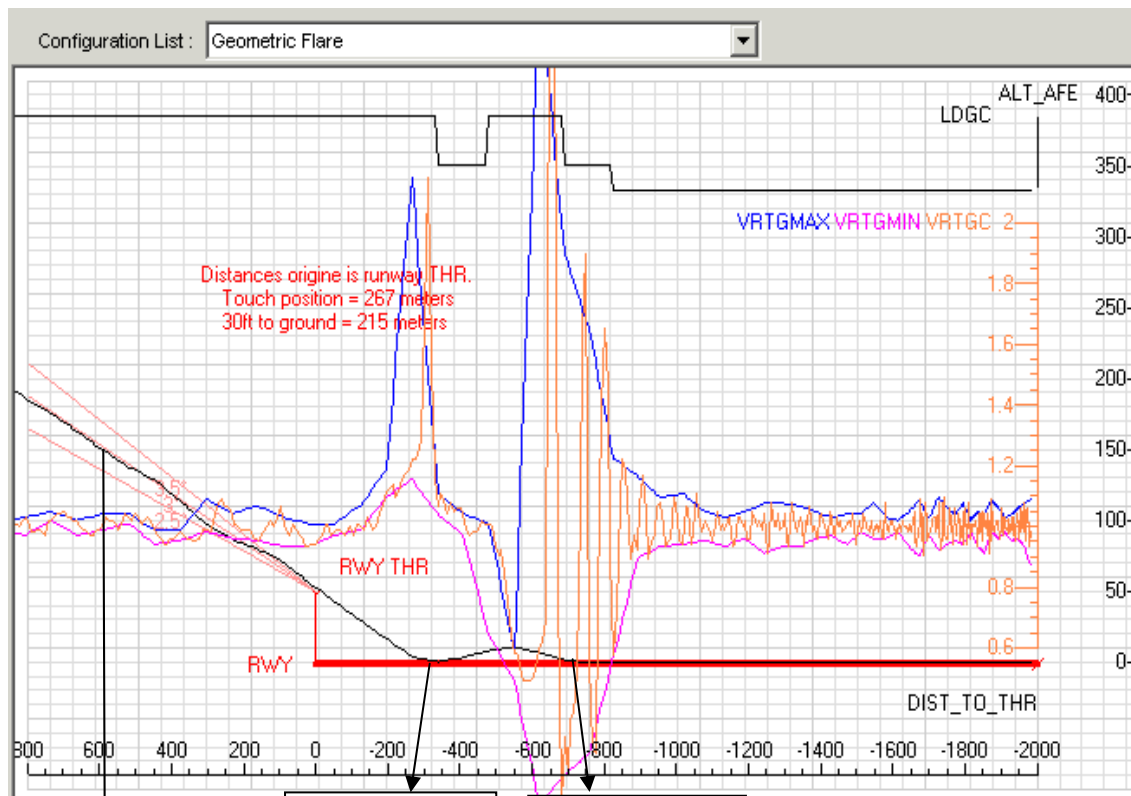
- At 20:35:16,5 hours:
  - PF ordered nose-down and the pitch, until then at 4.5 degrees nose-up, start decreasing;
  - Both THR levers were transiently moved out from *IDLE* notch.

Pic. 14 – Both touchdown main landing gears graphic.

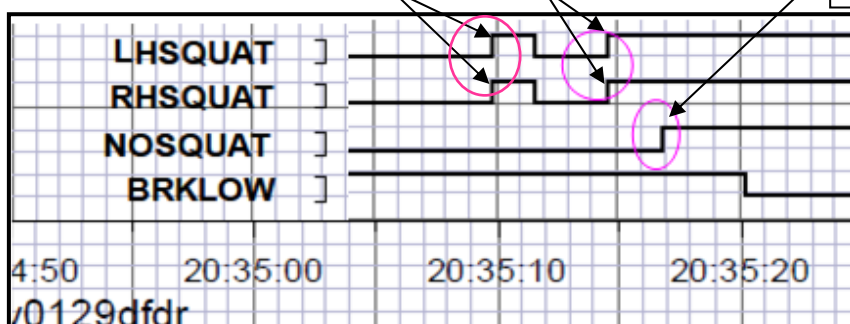
Pic. 15 – Main and nose gears' sensors graphic.
