**MINISTÉRIO DAS OBRAS PÚBLICAS, TRANSPORTES E COMUNICAÇÕES
GABINETE DE PREVENÇÃO E INVESTIGAÇÃO DE ACIDENTES COM AERONAVES**

FINAL ACCIDENT REPORT

CS-HFB

FINAL ACCIDENT REPORT Nr. 18/ACCID/2009

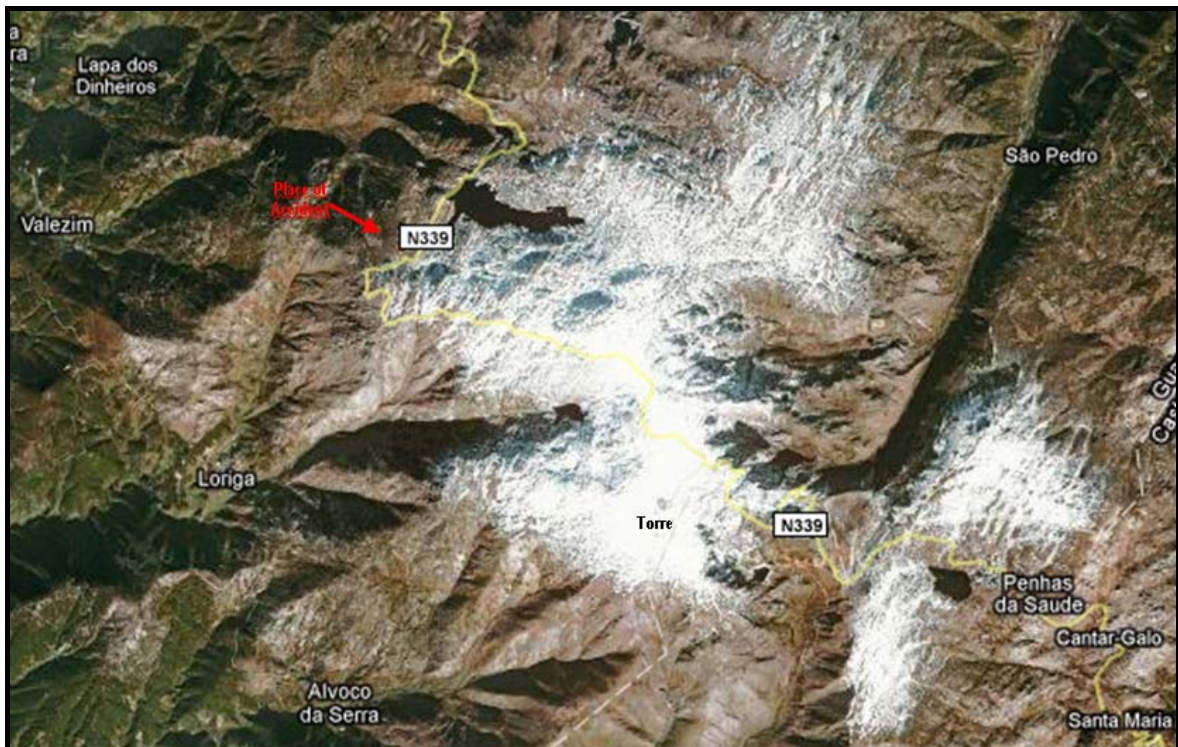
Picture Nr. 1

That morning some takes have been performed along a road connecting Loriga with Seia and passing near Lagoa Comprida (*picture nr. 1*).

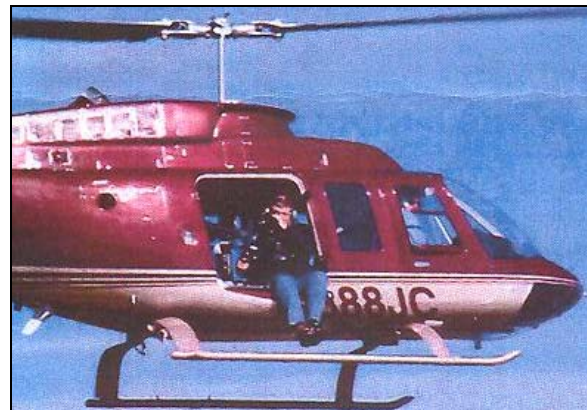
Picture Nr. 3

In front of him was the camera mounting and support pod (*picture nr 3*).

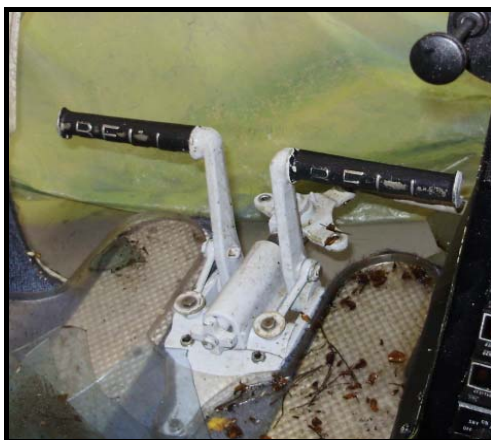
Picture Nr. 4

For safety reasons and complying with legal requirements, left seat flight controls had been removed but the pedals, which had been inhibited, by disconnecting them from actuating system, and were only used as footrest, having no movement at all (*picture nr 4*).

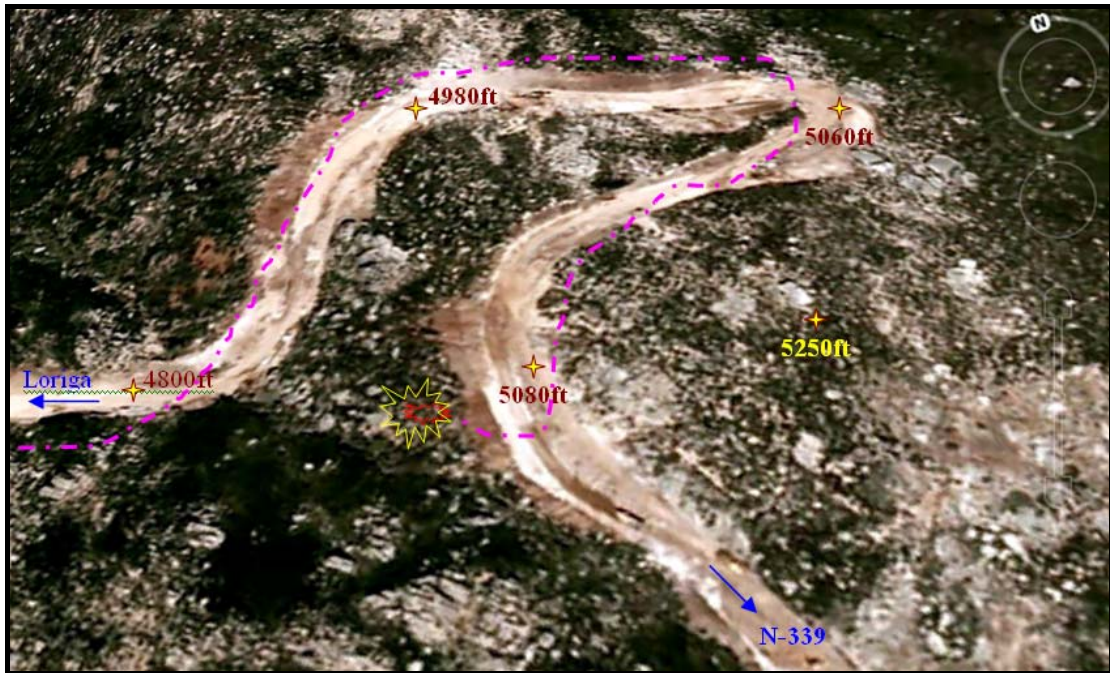
Picture Nr. 8

The accident occurred in a mountainous region (Serra da Estrela) located at 40° 21' 29" N / 007° 39' 57" W, altitude 5060ft on a high slope with level differences of 4900ft to 5100ft (*picture nr 8*).

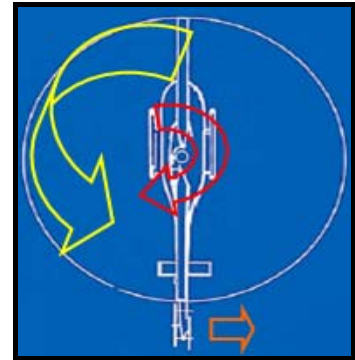
Picture Nr. 11

Tail rotor is intended to counteract torque effect generated by main rotor rotation and to provide a smoother and coordinated flight (*picture nr 11*).

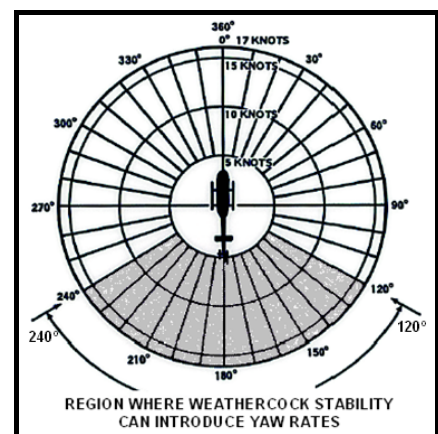
Picture Nr. 12

When the wind comes from the shaded area (*picture nr 12*) and a rotation is initiated to any side, that rotation will suffer an acceleration on the same direction, unless timely opposite pedal force is applied, to prevent high yaw rates.

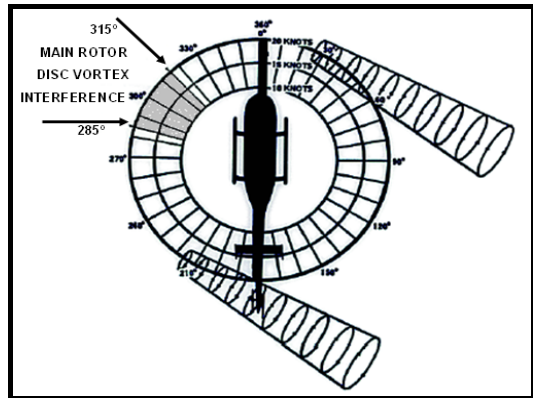
Picture Nr. 13

When the wind comes from 285° / 315° (shaded area on picture nr 13) the vortex generated by main rotor blades may be directed onto the tail rotor, changing its angle of attack.

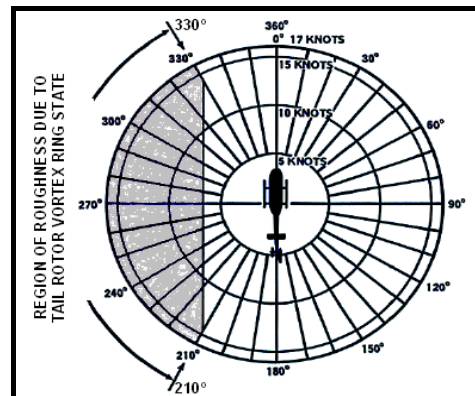
Picture Nr. 14

If relative winds are blowing from 210° / 330° (shaded area on picture nr 14), there's the possibility of development of vortex ring state of tail rotor, which causes tail rotor thrust variations resulting in yaw rates. Having not a specific period, the pilot must make corrective pedal inputs as the changes in yaw accelerations are recognized. This resulting high pedal workload in tail rotor vortex ring state is routinely applied, as helicopters usually fly in this region.
