FINAL ACCIDENT REPORT

Alon A2-A (Aircoupe)

CS-AIG

FINAL ACCIDENT REPORT Nr. 01/ACCID/2010

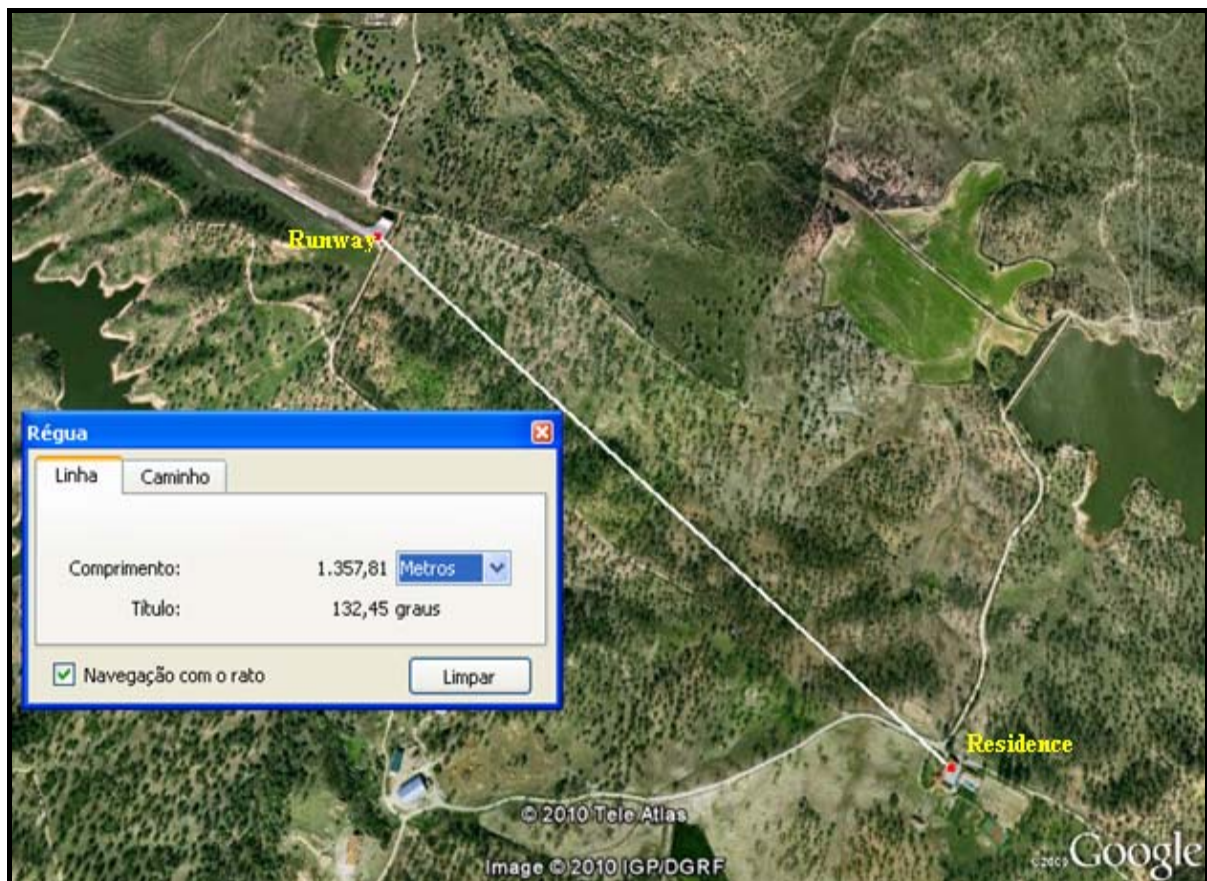
Picture Nr 1

By 16:00, the farmer took them to the airfield, helped to open hangar doors and put the aircraft outside, after which returned home, located on top of a hill, approximately 1350m south-east of runway (*picture nr 1*), letting pilot and passenger, at the aerodrome, preparing the aircraft for the flight.

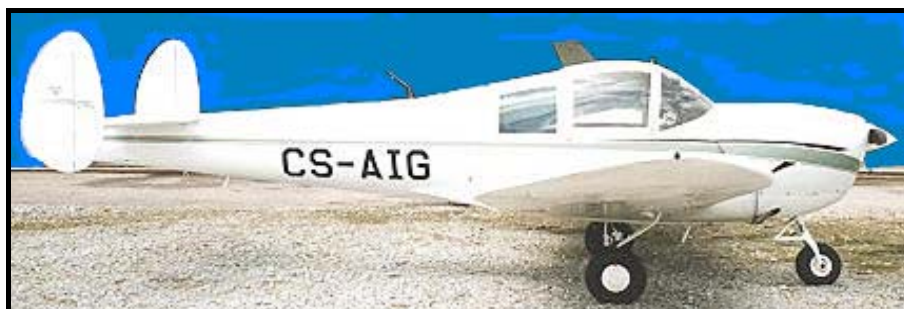
Picture Nr 3

The aircraft (*picture nr 3*) was a single engine, low wing, tricycle fixed landing gear aircraft, with capacity to carry two people and a Maximum Take-off Mass (MTOM) of 1450lbs (657kg).

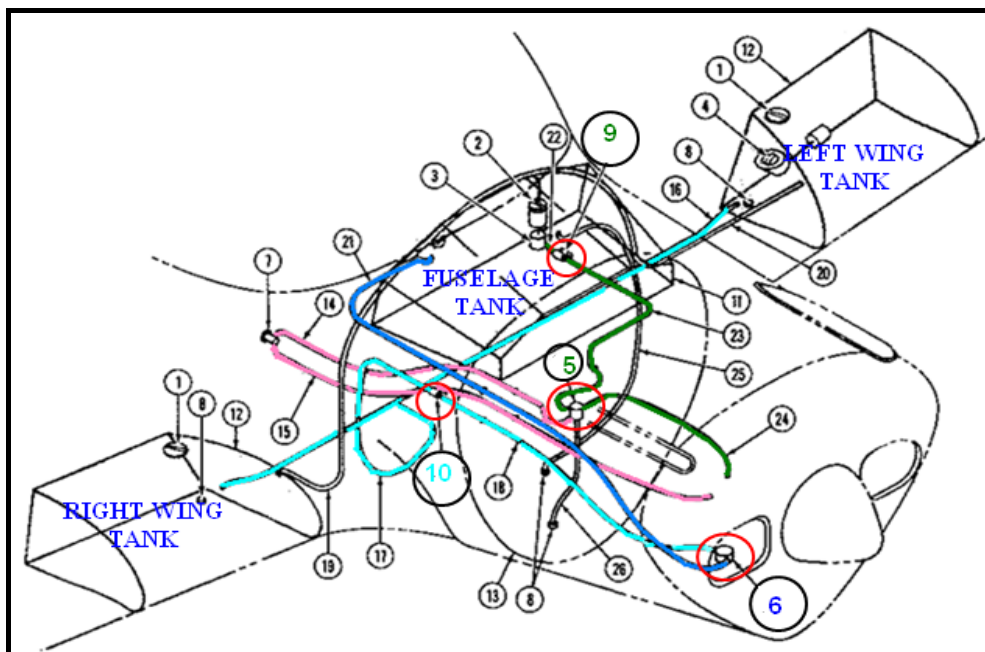
Picture Nr 4

The Aircoupe fuel system consists of two wing tanks, a gravity fuselage tank, fuel pump, primer, fuel drains and a filter (*picture nr 4*).

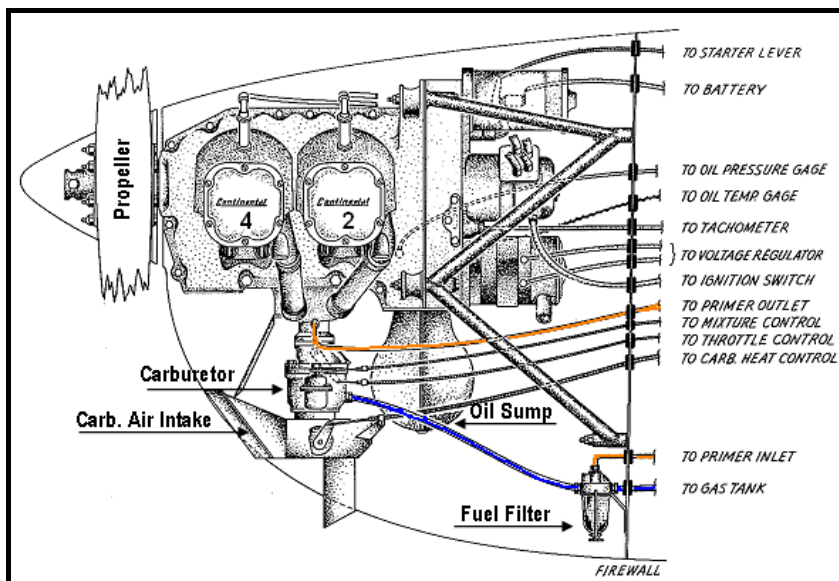
Picture Nr 5

The Continental C90 engine is a carburetted, horizontally opposed, four cylinder four stroke, spark-ignited, air-cooled, wet sump engine incorporating a bottom induction and exhaust system, and provisions for rear mounted accessories (*picture nr 5*). It is rated to 90HP at sea level, standard atmosphere and 2475RPM.

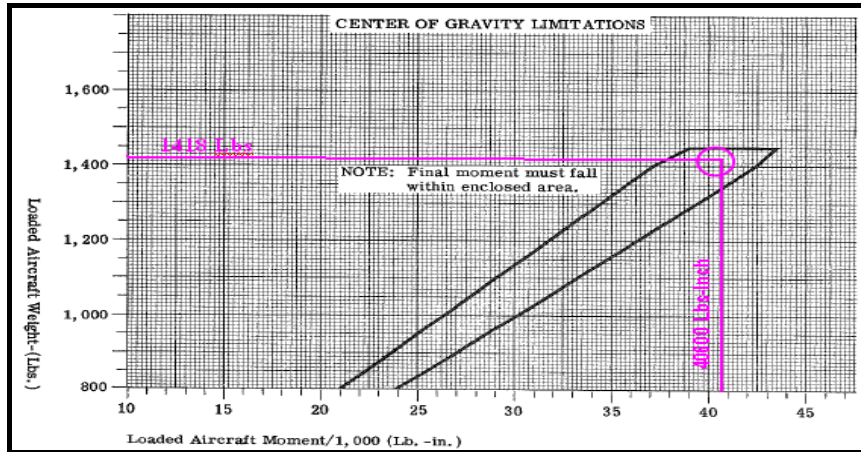
Graph Nr 2

Aircraft Centre of Gravity was inside allowed take-off envelope (graph nr 2), which confirmed the Aircraft Load & Balance was correct and within recommended operation limits, at take-off.

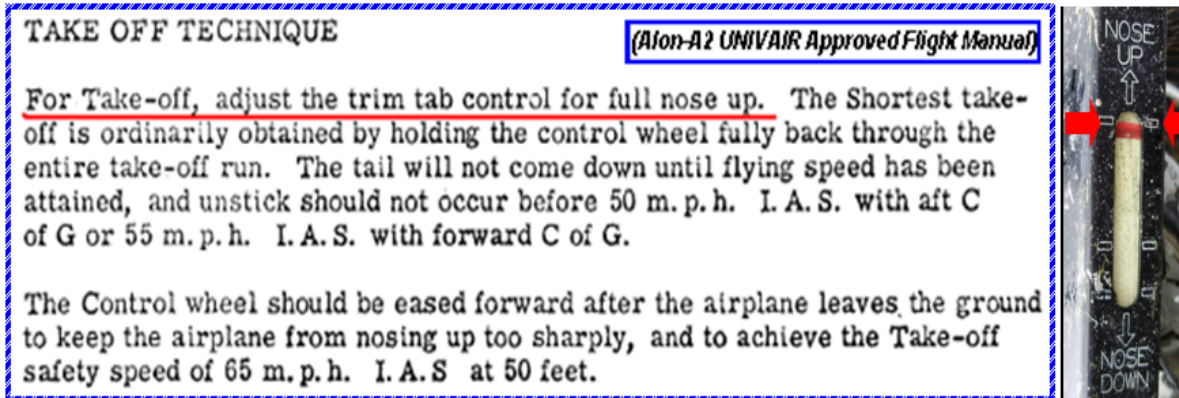
Picture Nr 26

Concerning take-off phase, following recommendations were displayed on Univair Aircraft Corporation Approved Aircraft Flight Manual (picture nr 26):

From cockpit interior's inspection, engine and flight controls' position and other switching, we deduced the pilot used take-off procedure recommended on AFM, section IV (*picture nr 26 in 2.1.1.2*).

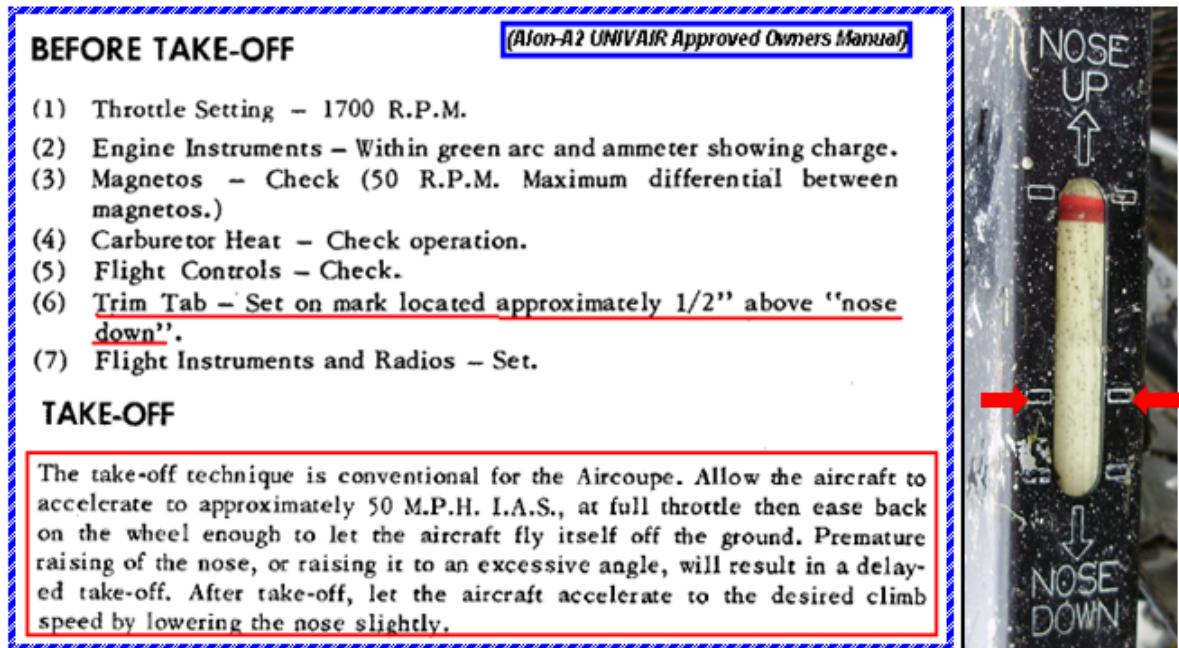
Picture Nr 27

Curiously on the Alon A2 Aircraft Owners Manual, issued by the same company (Univair Aircraft Corporation), a substantially different take-off technique and procedure is explained, recommending a pitch trim setting backwards to a reference mark and making the take-off run with flight controls at a neutral position until lift-off speed (reducing drag) when a gentle easing back of pitch control will take the aircraft off the ground (picture nr 27):

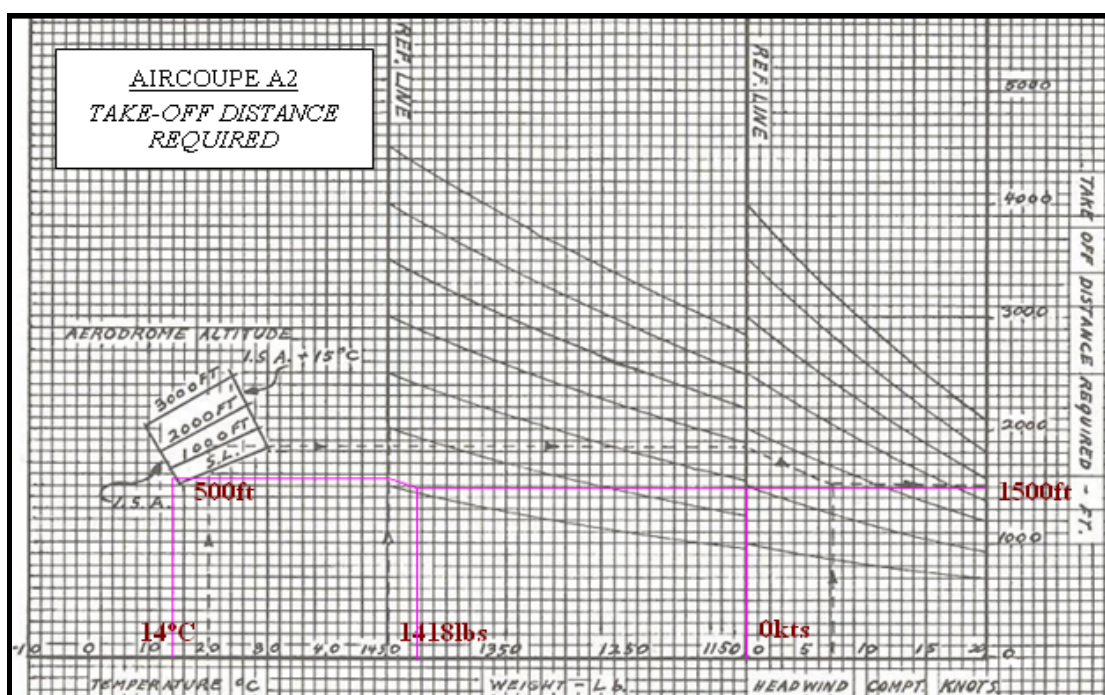
Graph Nr 3

Being determined that the actual take-off mass of **1418lbs** was below the maximum permissible take-off mass for that altitude and temperature (ISA conditions) and maximum structural take-off mass (1450lbs), actual values were introduced on "Take-Off Distance Required" graph (*graph nr 3*). Minimum take-off required distance found was 1500ft, for a zero wind condition, once the graph had no provision for tail wind correction.

Being Runway Take-Off Distance Available (TODA) 1783ft, the runway should accommodate aircraft take-off in such conditions, even if the pilot took position in front of the hangar (1740ft), provided tail wind effect was not to be considered.

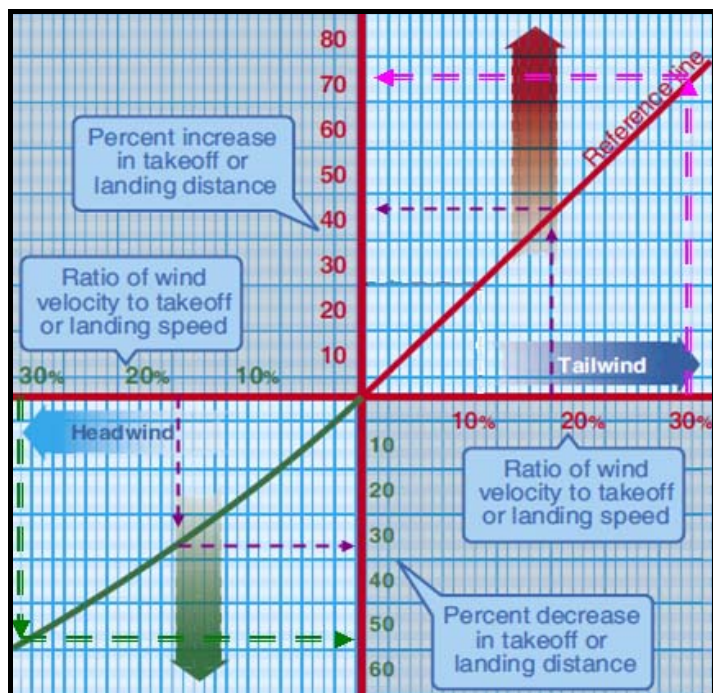
Picture Nr 29

Once the Aircraft Flight Manual presents no correcting table for tail wind, a tail wind take-off shall not be attempted, unless relevant factors so determine. Even so it must be considered that for strong winds, there should be a heavy penalty and take-off in such circumstances may be not achievable. Making use of FAA "Pilot Handbook of Aeronautical Knowledge" again, we will try to show how penalizing strong tail wind could be, introducing the actual tail wind of 16MPH (14kts) on the chart (*picture nr 29*).

Considering a take-off speed of 50MPH, actual tail wind represents 32% of that speed and it would require a 75% increase of take-off distance, against 57% decrease if it was a head wind (*large dotting*). Complying with AFM recommendation that the grid on graphs is not compensated and a corrective factor of 50% should be applied, we may find, for a wind factor of 16% a 45% distance increment or 35% distance decrement respectively for tail and head winds (*fine dotting*).

In such conditions, even applying the less penalizing coefficient (45% increase on take-off distance required), instead of 1500ft determined for zero wind (2.1.2.1), the new take-off distance required would be 2175ft. Considering the runway had 1783ft only, take-off in those conditions was seriously endangered.

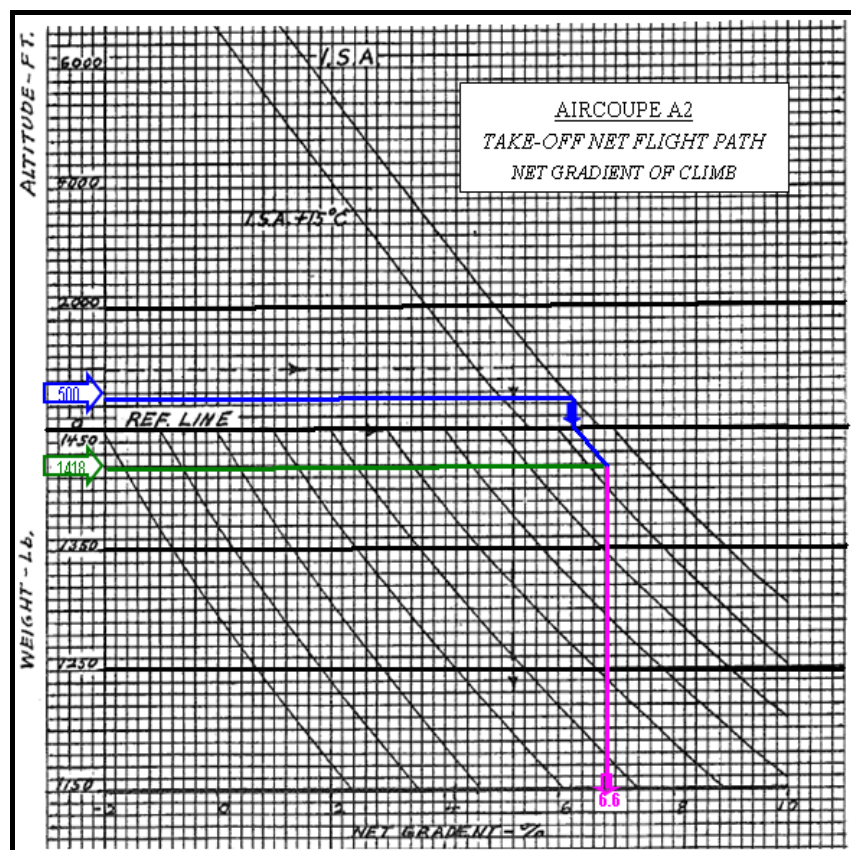
Graph Nr 4

Introducing altitude value of 500ft on the graph and proceeding to temperature reference line for ISA (14°C), following to intercept weight line of 1418lbs and going down to Net Gradient scale a 6.6% figure is obtained, which means the aircraft may climb 6.6ft for every 100ft horizontal distance covered.

With this figure it becomes easy to determine the possibility of the airplane to clear present obstacles on its take-off path.

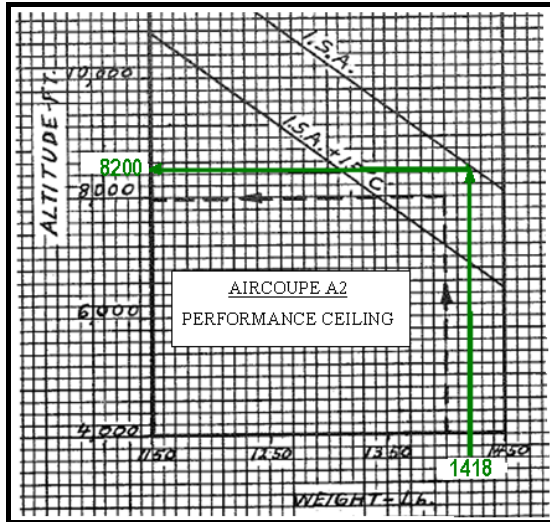
Graph Nr 5

Aircraft “ceiling” means the maximum altitude which the airplane may regularly relied upon to achieve, bearing in mind the adverse conditions likely to occur. At that altitude the aircraft should maintain an airspeed of 70MPH at sea level reduced by 1MPH for every 1000ft altitude, up to the limit of 62MPH minimum, with full throttle and carburettor air intake selected to cold air. Regarding our analysis, that ceiling would be 8200ft (*graph nr 5*).
