SERIOUS INCIDENT

Aircraft Type and Registration:	BAE Systems (Operations) Ltd ATP, SE-MHE	
No & Type of Engines:	2 Pratt & Whitney Canada PW126 turboprop engines	
Year of Manufacture:	1989 (Serial no: 2012)	
Date & Time (UTC):	14 February 2018 at 0700 hrs	
Location:	In flight from East Midlands to Guernsey Airport	
Type of Flight:	Commercial Air Transport (Cargo)	
Persons on Board:	Crew - 2	Passengers - None
Injuries:	Crew - None	Passengers - N/A
Nature of Damage:	None	
Commander's Licence:	Airline Transport Pilot's Licence	
Commander's Age:	42	
Commander's Flying Experience:	8,500 hours (of which 6,500 were on type) Last 90 days - 84 hours Last 28 days - 22 hours	
Information Source:	AAIB Field Investigation

Synopsis

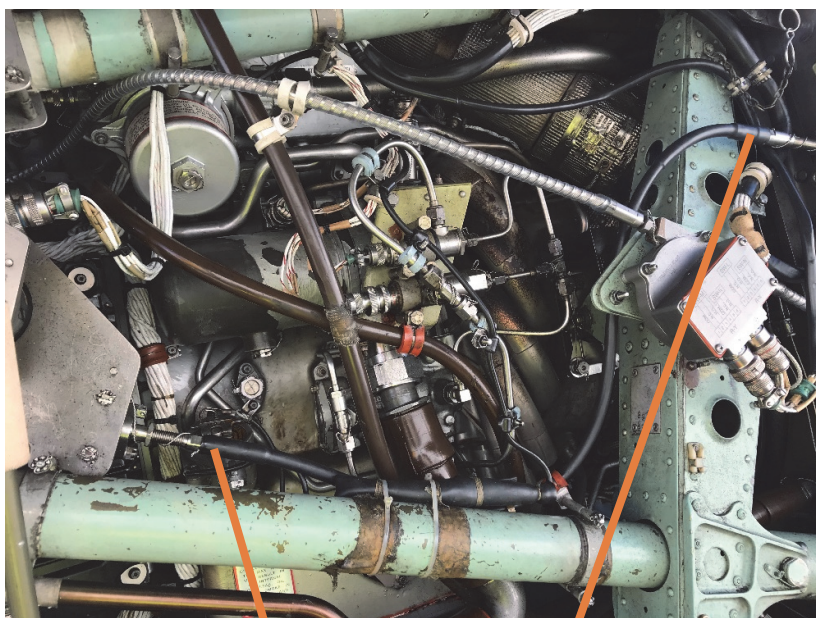
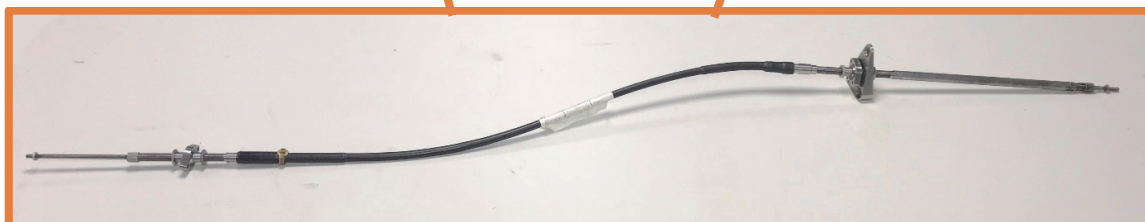
Figure 7

Between 2014 and 2018, the operator recorded six events on their ATP fleet where pilots reported 'restricted', 'stiff / notchy' or 'frozen' power levers. There was no confirmed link between the events but the engine power 'Bowdenflex' control cables were cited as a possible cause because of their apparent susceptibility to moisture ingress and freezing; the control cables are under the engine cowls (Figure 7).

Bowdenflex cable
