# **Technical Report 096/2011**

**Accident that occurred on 18 May 2011**

**Aircraft Saab 340 A, LV-CEJ. Location: Caltrauna,  
between Los Menucos and Prahuaniyeu, province of Río  
Negro**

**Civil Aviation Accident  
Investigation Board (JIAAC)**

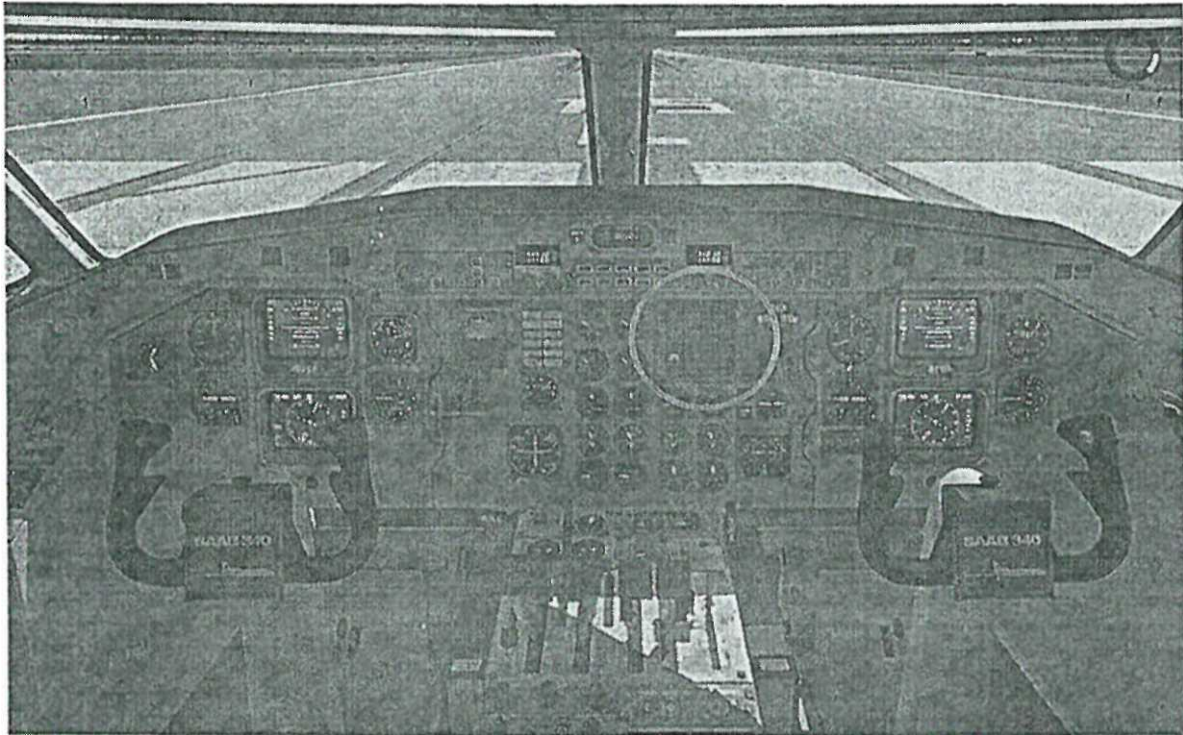
##### 1.16.4.4.2 Central Warning Panel - CWP

The Central Warning Panel (CWP) is composed of a total of forty (40) light indicators. Each of these indicators has two micro-incandescent lamps that light up simultaneously to give an announcement. In order to determine whether an alarm was activated at the time of the accident, the remains that could be retrieved were sent to the manufacturer's facilities for referral (under the supervision of SHK Sweden).

*Blueprint of the cockpit, which details the location of the central alarm panel.*

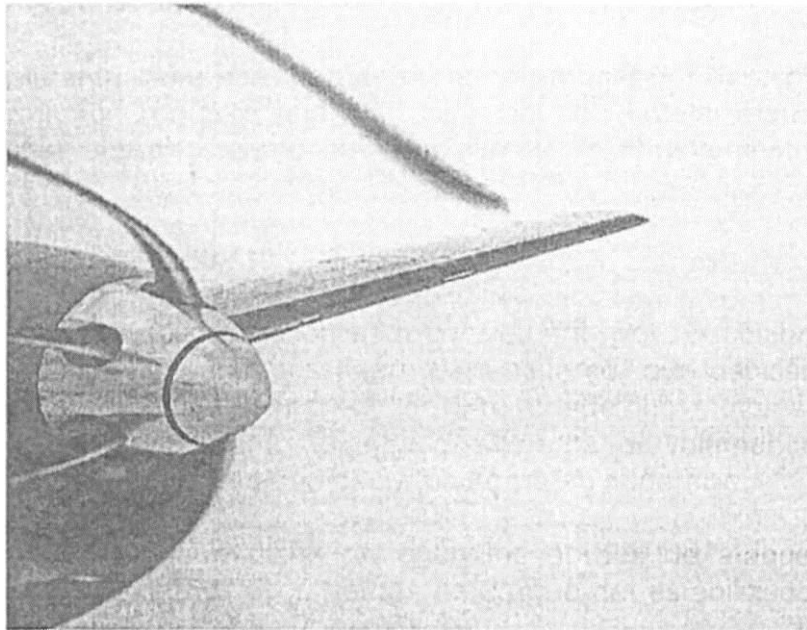
This protection system consists of a set of resistant, hollow, rubber leading edges (inner tubes) , which are associated with the pneumatic system of the aircraft. They cyclically bleed air from the engines, and inflate and deflate. While inflated, the volume of the leading edges increase, which then dislodges ice which was formed on its surface.

These pneumatic boots protect the wing's leading edges (internal as well as external) and the leading edges of the vertical and horizontal stabiliser.

*An example of the location of the leading edge's de-icing boots in a similar aircraft.*

According to the AFM, in order for the boot system to be properly effective, it should be put into operation as soon as there is the slightest formation of ice. The correct use and cycle of the system prevents the formation of "ice bridging", which is a phenomena that occurs when the boot is not fully
