## *Final report RL 2017:08e*

**Serious incident at Malmö Airport on 29 September 2016 involving SE-DSP of the model AVRO 146-RJ100, operated by Braathens Regional Aviation AB.**

File no. L-101/16

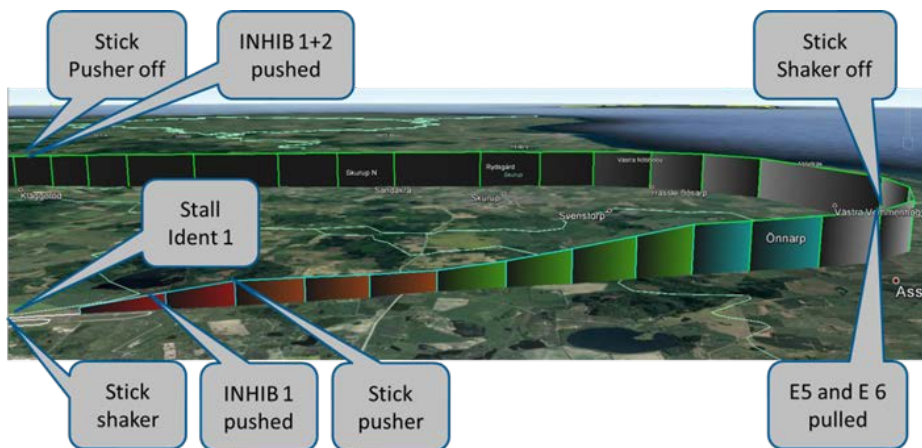
Figure 1. Part of the aeroplanes track according to radar data at take-off from runway 17. Map from Google Earth.

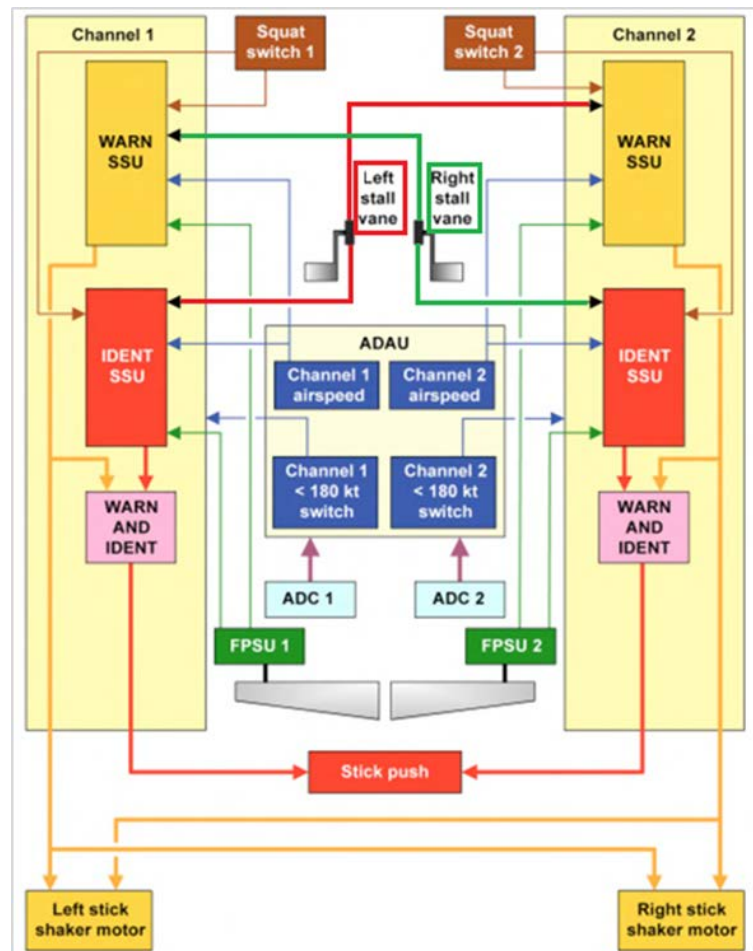
Each SSU converts the vane angle to angle of attack. Each WARN SSU will give an output when it senses that the stall warning angle has been reached and each IDENT SSU will give an output when it senses that the stalling angle has been reached. If a WARN SSU detects that stall warning angle has been achieved, the WARN SSU activates both stick shakers. (See fig. 3).

Figure 3. Simplified schematic of the stall protection system, electronic control.

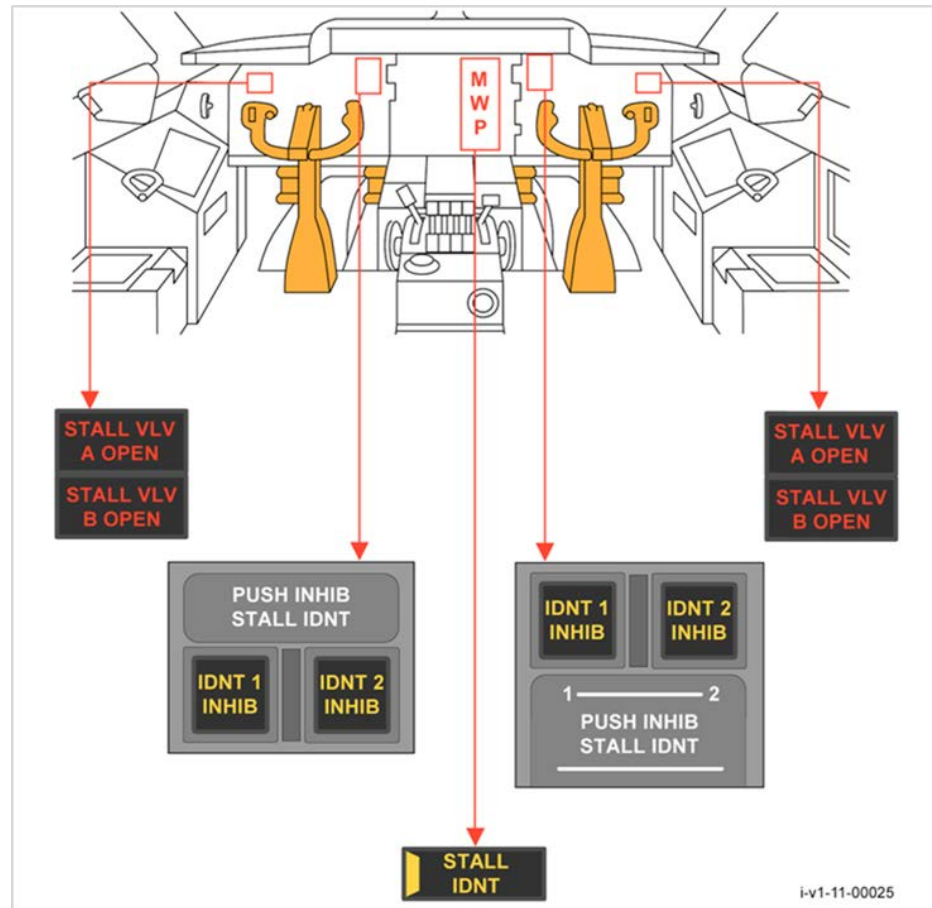
To prevent a subsequent false push being given, the channel is inhibited by pressing either of the channel's stick push inhibits switches (IDNT/INHIB) (see fig. 4). Both INHIB annunciators for the failed channel will illuminate and the channel remains inhibited for the rest of the flight. A reset can only be made on the ground. The other channel can still give a push if the stalling AOA is reached.

Figure 4. Stall system annunciators on the instrument panel.

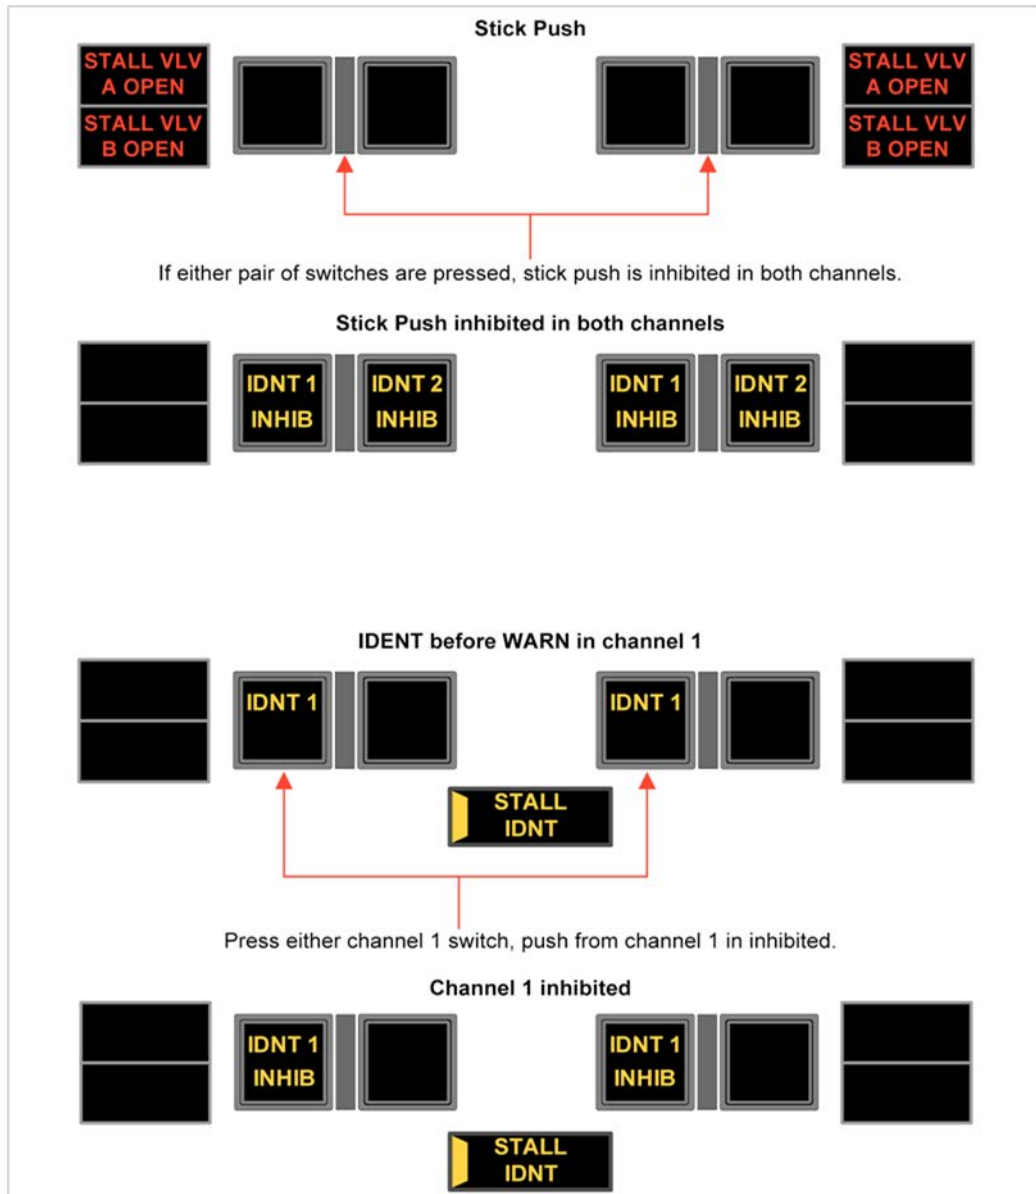
If a false stick push is given, the pilot can overpower the pusher. If both the channel 1 and channel 2 switches are pushed simultaneously, the stall valves will be forced closed and the push will cease. All four INHIB annunciators and all four IDNT annunciators will illuminate. Stick push is lost for the remainder of the flight. (See fig. 5 and 6).

Figure 5. Stall annunciators at different scenarios.

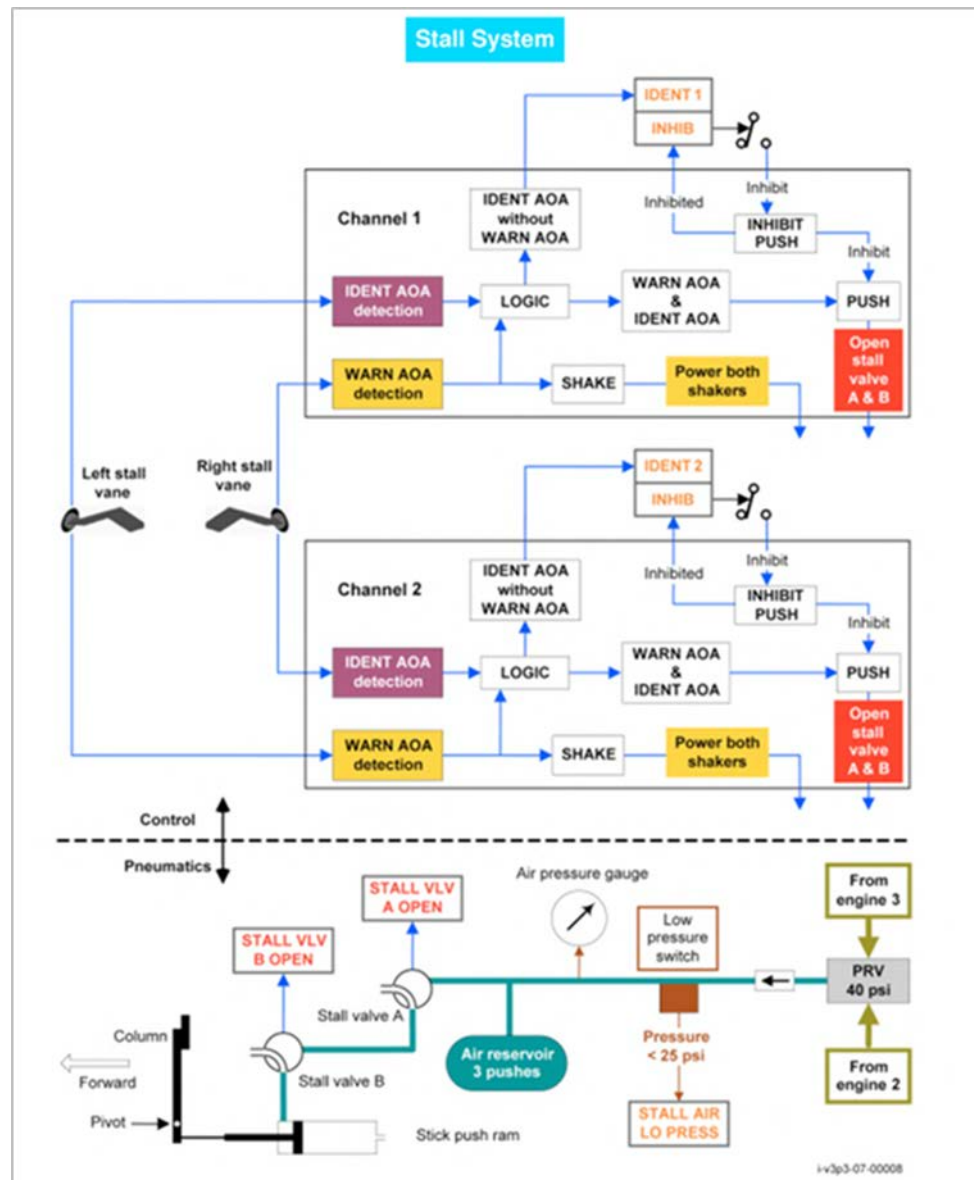
Figure 6. Simplified schematic of the stall system with the pneumatic system under the dotted line.
