Final report RL 2013:09e

**Accident on 11 August 2012
involving the aircraft N-84142
on the lake Hultebräan, Kalmar County.**

Ref no L-83/12
2013-04-25

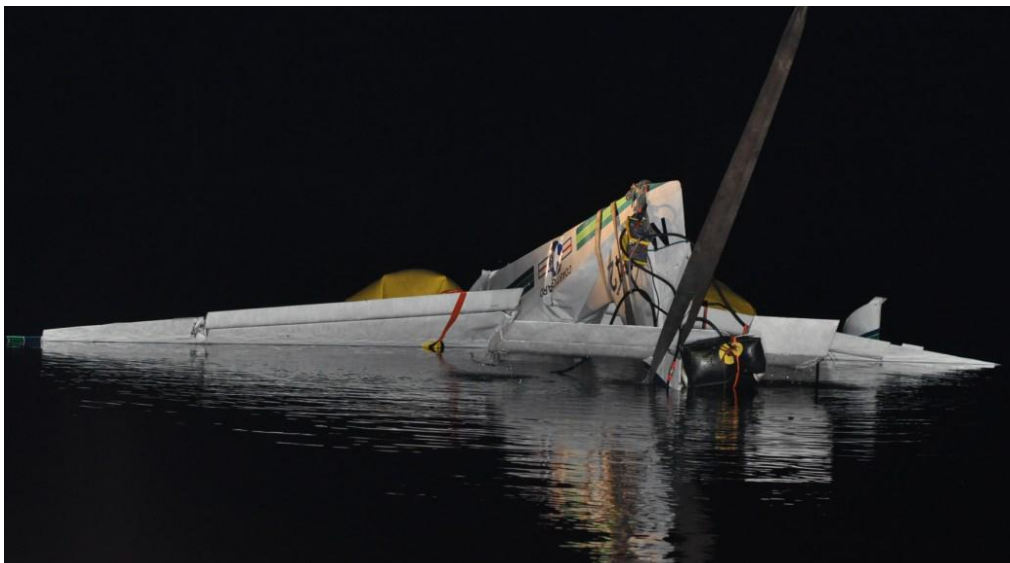
Fig. 7. The aircraft lying upside down on the surface of the water after having been lifted with inflatable lifting cushions. Photo: Göran Johansson, Sydostnyheter.

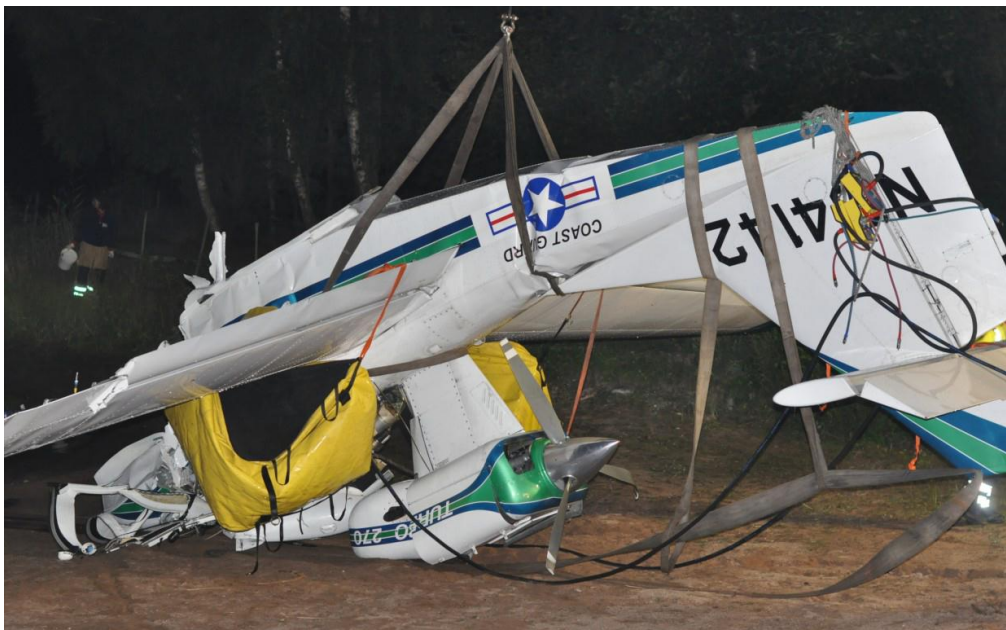
Fig. 8. The aircraft was placed upside down on the ground. Photo: Göran Johansson, Sydostnyheter.
