# Air Accident Investigation Sector

- Final Report -

AIFN/0019/2014

## Passenger Ejected from Balloon Basket during Landing

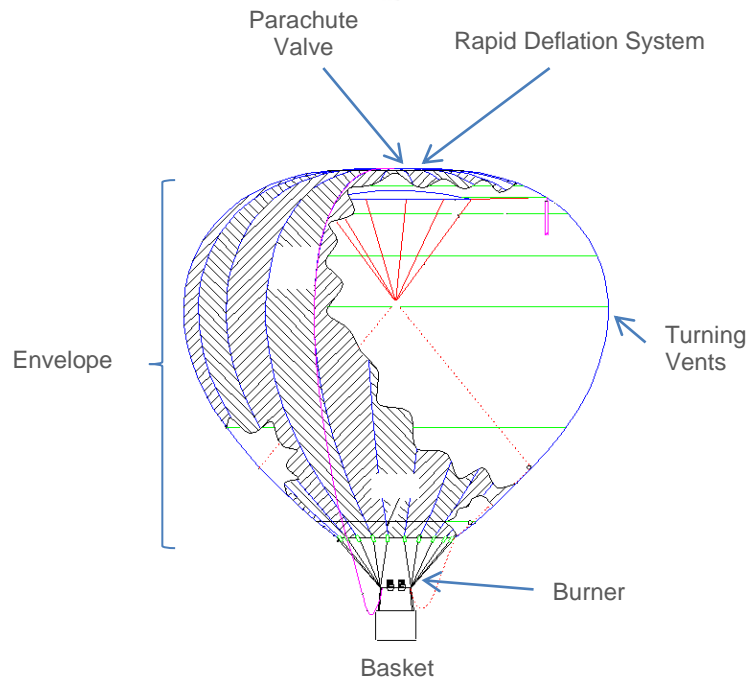
Figure 1. Typical balloon configuration

The Rapid Deflation System (RDS) is a pilot actuated system which opens a section at the top of the balloon to vent the captured hot gases to atmosphere. In the Cameron balloon design, the RDS is actuated by a rope from the pilot's position via a pulley system to the RDS at the top of the balloon envelope.
