## **AIRCRAFT ACCIDENT REPORT**

**GRAND CANYON AIRLINES, INC.,  
AND HELITECH, INC.,  
MIDAIR COLLISION OVER  
GRAND CANYON NATIONAL PARK  
JUNE 18, 1986**

**NTSB/AAR-87/03**

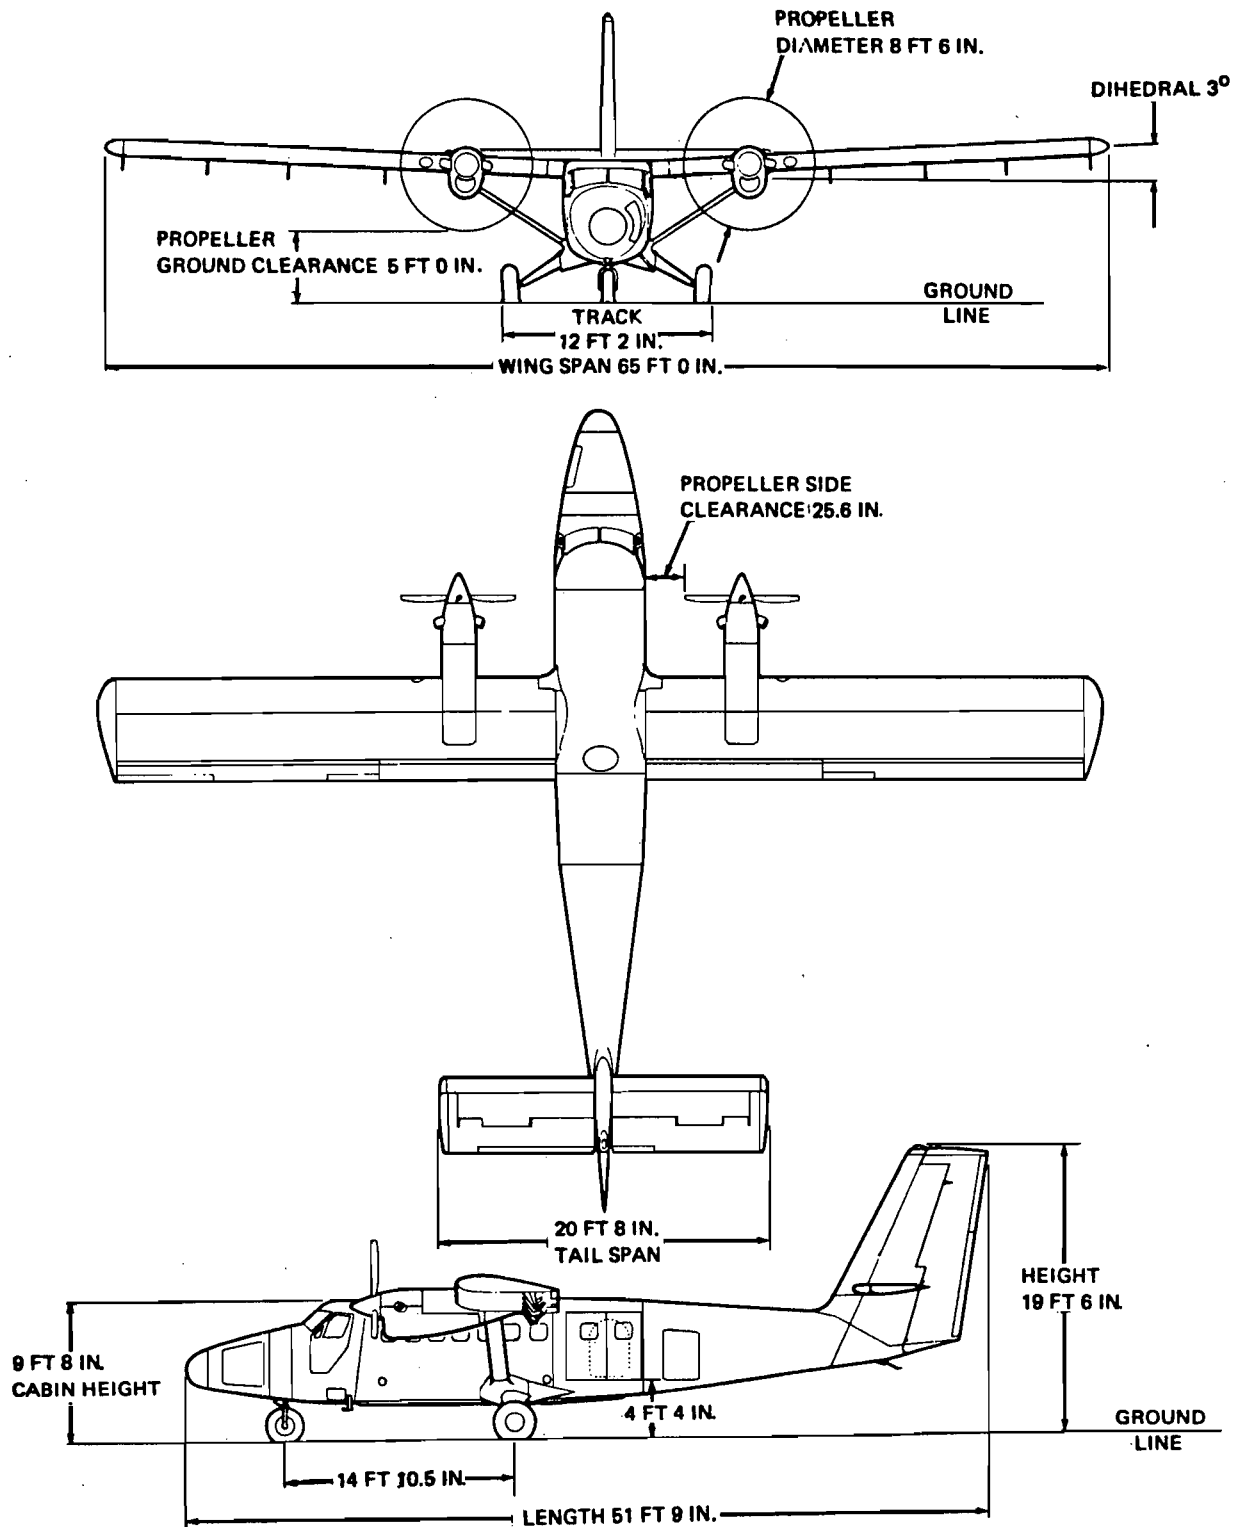
**Aircraft Dimensions**

**DE HAVILLAND CANADA  
DHC-6 TWIN OTTER SERIES 300  
MAINTENANCE MANUAL**

**Figure 2.--Aircraft dimensions -- the DHC-6-300.**

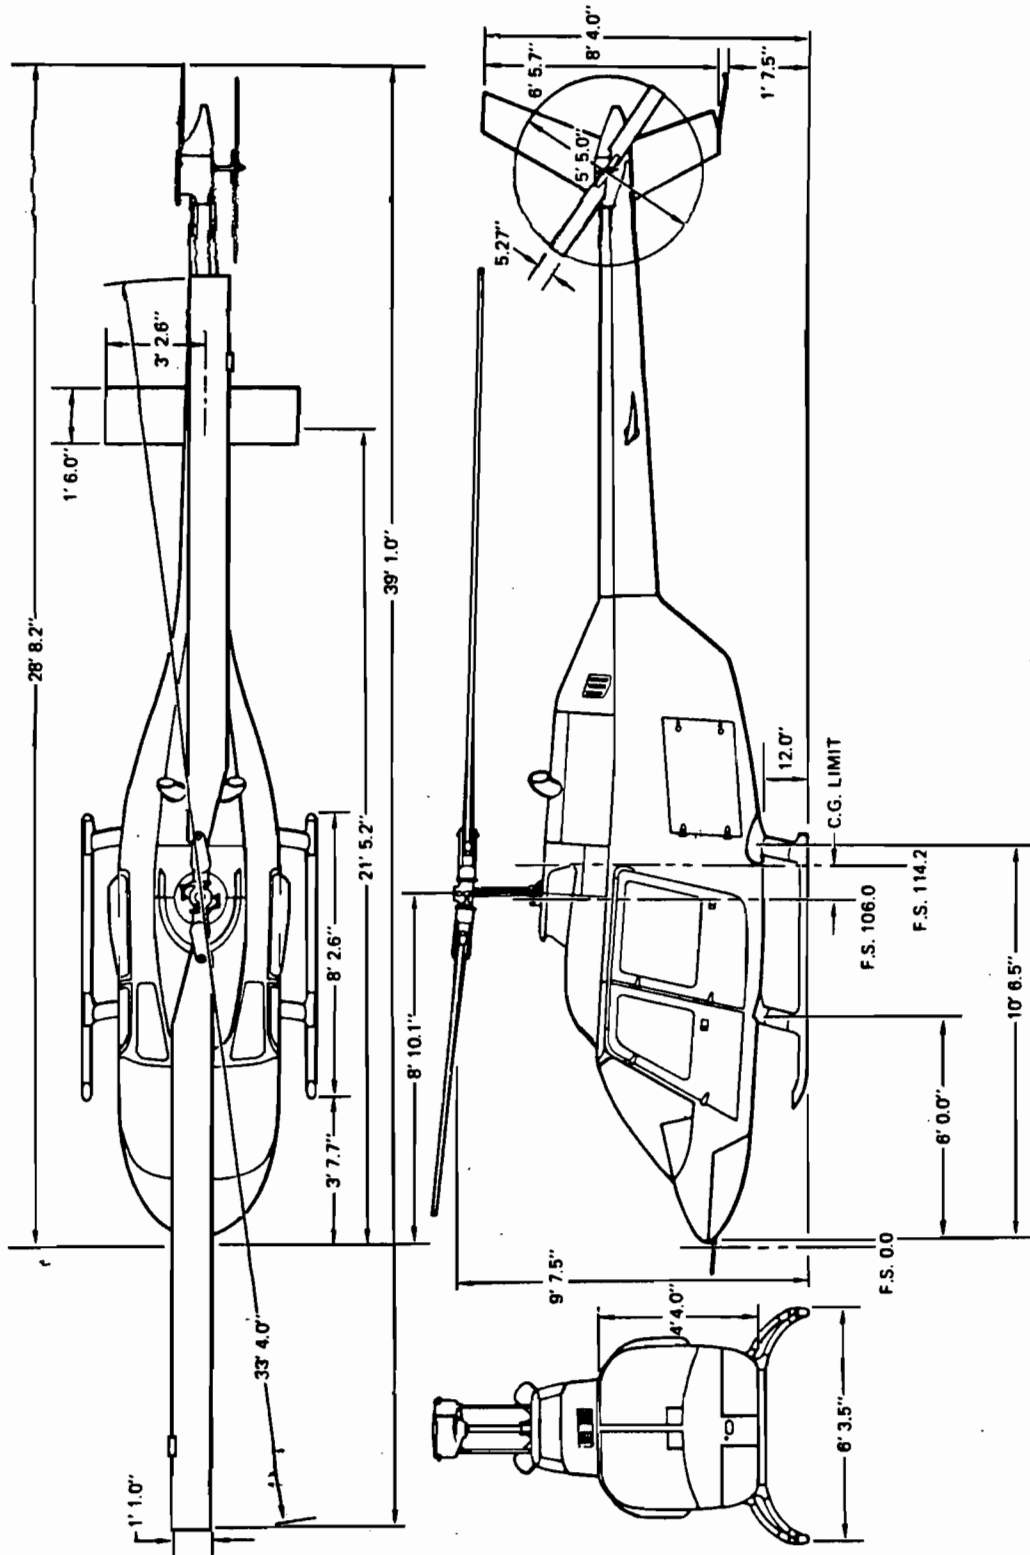
Figure 3. Aircraft dimensions—the Bell 206B.

The Bell 206B III, Jet Ranger, United States Registry N6TC, was a single-engine, utility-type helicopter. It was configured for a pilot and one passenger in the front seats and three passengers in a rear bench-type seat. It was equipped with an Allison 250-C20B powerplant, a two-blade main rotor and a two-blade tail rotor. (See figure 3.) The aircraft was painted white and yellow with yellow the predominant color of the passenger cabin. The main rotor color was gray and the tail rotor was mostly red.
