# **Schlussbericht des Büros für Flugunfalluntersuchungen**

**über den Fastzusammenstoss**

zwischen dem Flugzeug F-100, HB-IVH, und dem Flugzeug B-757, SX-BBZ

vom 23. April 1995

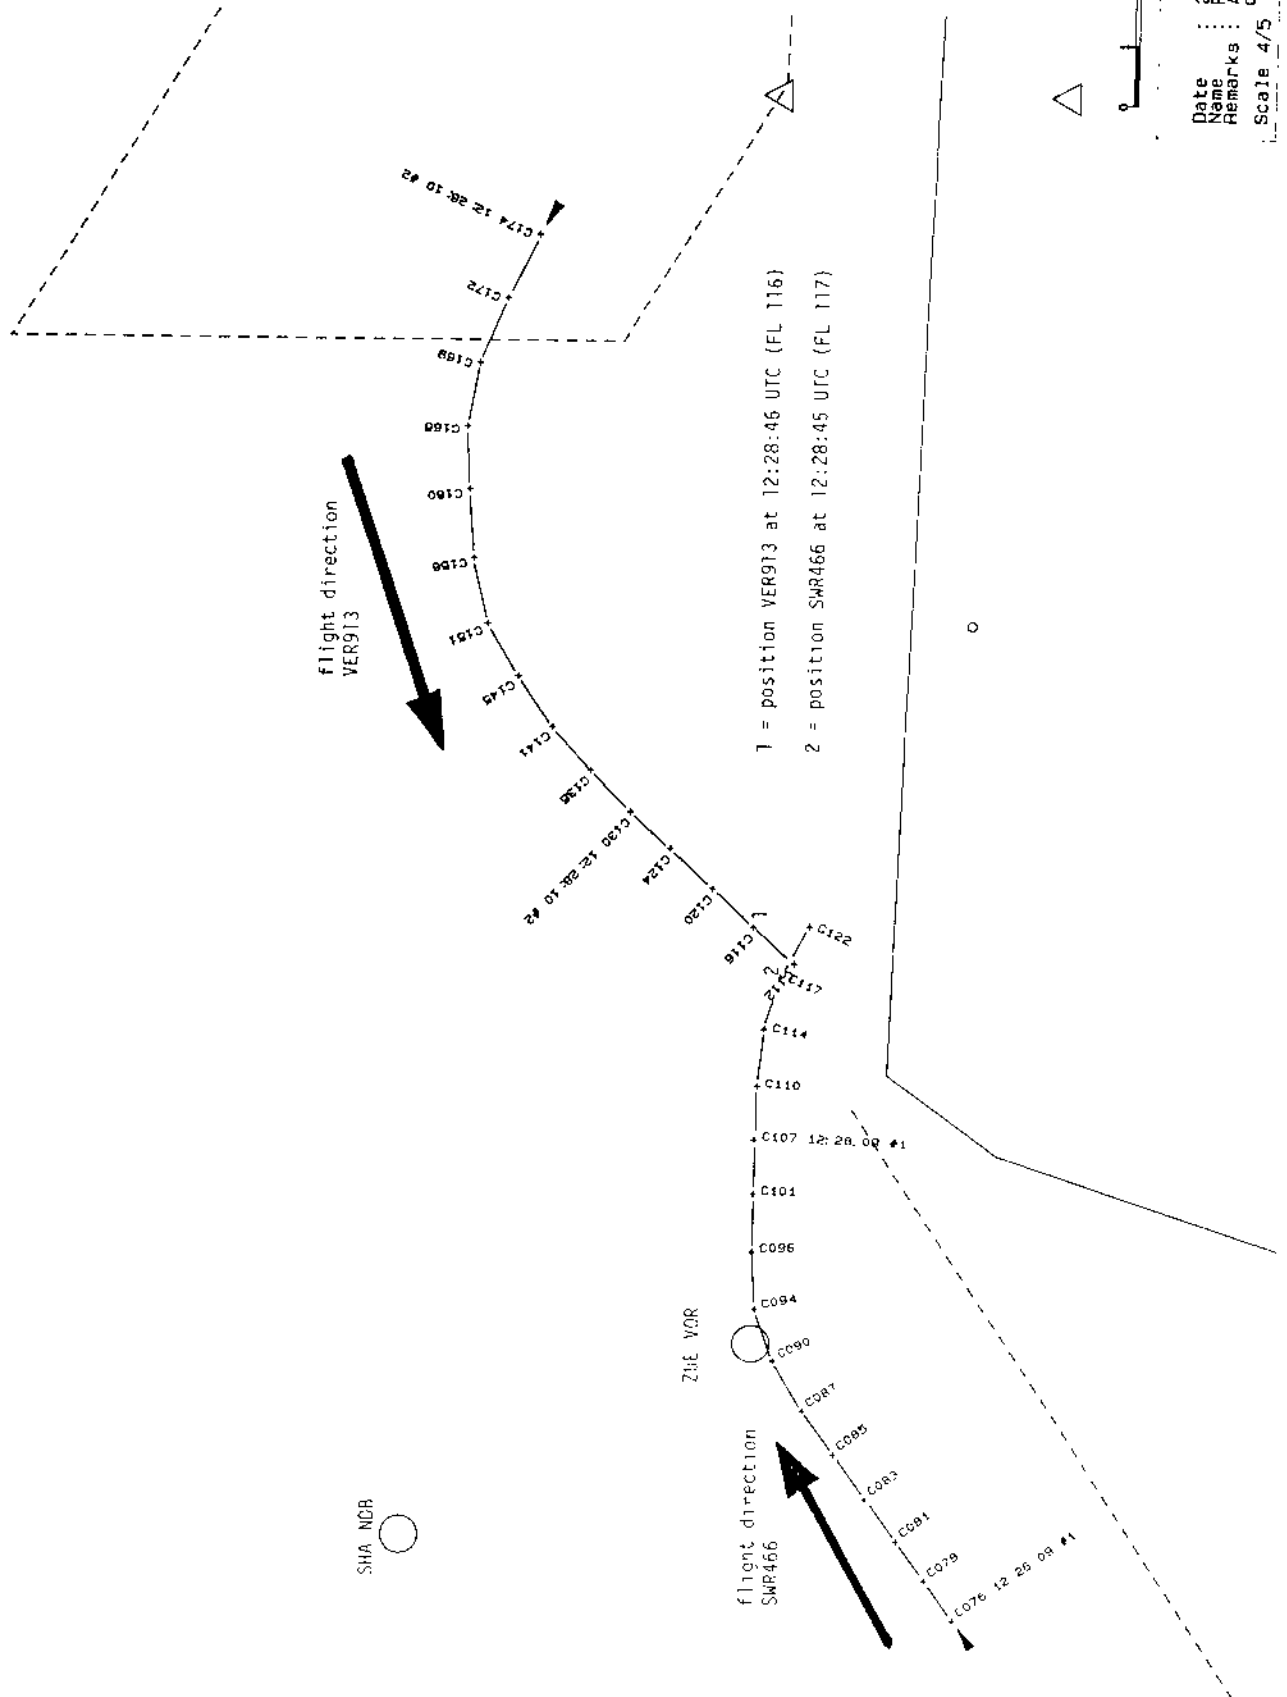
Recording Date: 23. Apr. 95  
Time: 12:00  
Plotting Time: 13:26

Sample 1 - SWA465  
Sample 2 - VER913
